Access Compliance Report

Public Rights-of-Way

(Curb Ramps)

Intersection ID: 44446	Main Street: REAMES_RD	Cross Street: PRESTBURY_BV	Location: SW
ADA ID: 84AEF0A58E78	Ramp Type: PerpDiag	Initial Pass/Fail: Fail	Overall Compliance: No
		Severity Score: 12.5

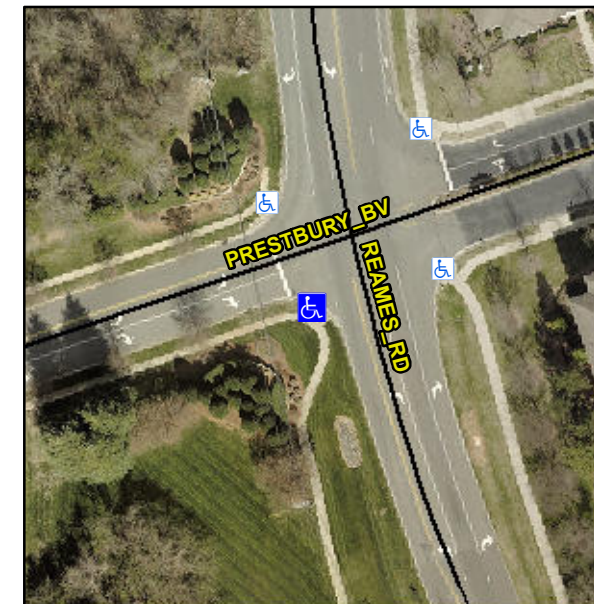
Not Found, R304.5.3

Compliance	Description	Data	Compliance	Description	Data
N/A	Ramp Length (in)	60.0	Yes	Ramp Slope (%)	6.5
Yes	Ramp Width (in)	53.0	No	Ramp XSlope (%)	5.4
N/A	Flare Type LT	N/A	N/A	Flare Type RT	N/A
N/A	Flare Slope LT (%)	N/A	N/A	Flare Slope RT (%)	N/A
N/A	Flare Traversable LT?	N/A	N/A	Flare Traversable RT?	N/A
N/A	Landing Length (in)	N/A	N/A	DWS Provided?	N/A
N/A	Landing Width (in)	N/A	N/A	DWS Contrast?	N/A
N/A	Landing Slope (%)	N/A	N/A	DWS Length (in)	N/A
N/A	Landing X Slope (%)	N/A	N/A	DWS Full Width?	N/A
N/A	Landing Curb? (Y/N)	N/A	N/A	DWS Offset (in)	N/A
N/A	Shared Landing?	N/A			
N/A	Gutter Ponding?	N/A	N/A	Gutter Slope (%)	N/A
N/A	Gutter Lip Ht (in)	N/A	N/A	Gutter X Slope (%)	N/A
N/A	Painted X Walk1?	No	N/A	Painted X Walk2?	No
	X Walk 1 Direction	To E		X Walk 2 Direction	To N
N/A	X Walk 1 Width (in)	N/A	N/A	X Walk 2 Width (in)	N/A
	X Walk 1 Slope (%)	3.2		X Walk 2 Slope (%)	2.8
	X Walk 1 X Slope (%)	1.2		X Walk 2 X Slope (%)	3.2

N/A	Ramp inside XWalk1?	N/A	N/A	Ramp inside XWalk2?	N/A
	Road Slope (%)	3.8	N/A	Clear Space?	N/A
	Road X Slope (%)	4.0	N/A	Clear Space to XWalk (in)	N/A
N/A	Any Obstructions?	N/A	N/A	Storm Grate/Utility Hazard?	N/A
	Obstruction Type			Storm Grate/Utility Type	
		N/A			N/A
		Yes		Surface Condition? (G/P)	Good

Remove & Replace Curb Ramp With Two New Directional Ramps or Equivalent.
