# Access Compliance Report

## Public Rights-of-Way

### (Curb Ramps)

| Intersection ID: 12426 | Main Street: KENWOOD_AV | Cross Street: MIDWOOD_PL | Location: SW |

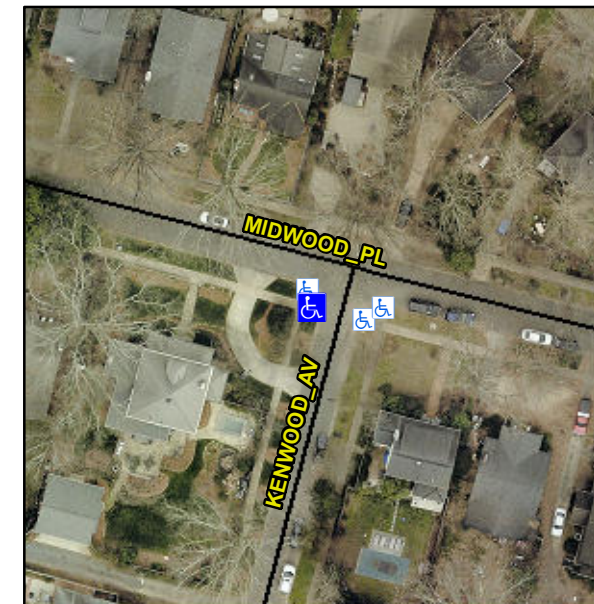
| ADA ID: 84CC26A78FE1 | Ramp Type: Directional1 | Initial Pass/Fail: Pass | Overall Compliance: No |
| | | | Severity Score: 2.5 |

| Compliance | Description | Data | Compliance | Description | Data |
|---|---|---|---|---|---|
| No | Landing Slope (%) | 2.8 | Yes | DWS Length (in) | 25.5 |
| No | Landing X Slope (%) | 2.3 | No | DWS Full Width? | No |
| Yes | Gutter Lip Ht (in) | 0.0 | No | Gutter X Slope (%) | 6.4 |

Possible Solutions:

**Remove & Replace Entire Ramp.  
Remove & Replace Gutter.**
