Access Compliance Report

Public Rights-of-Way

(Curb Ramps)

Intersection ID: 27962	Main Street: PINE_VALLEY_CLUB_DR	Cross Street: ROYAL_ABERDEEN_CT	Location: SW
ADA ID: 84E9EF5824D0	Ramp Type: Perp	Initial Pass/Fail: Fail	Overall Compliance: No
Severity Score: 22.5			
Codes/Mitigation Info/Possible Solution		Field Measurements/Component Compliance

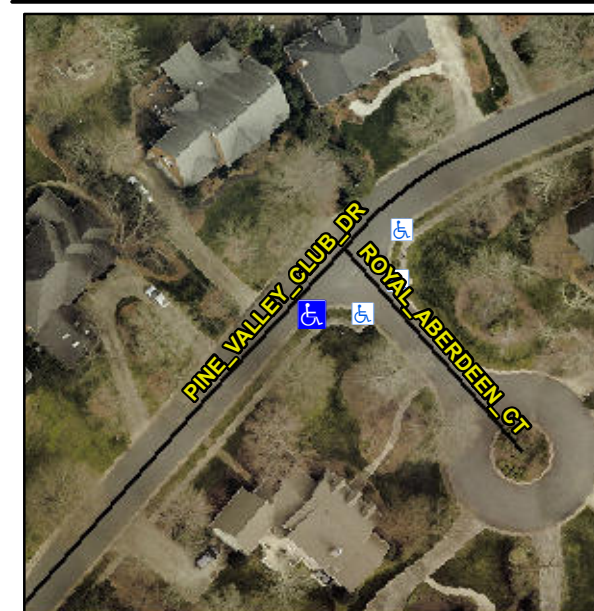
Not Found, R304.5.1, R304.2.2, R304.5.3

Compliance	Description	Data	Compliance	Description	Data
N/A	Ramp Length (in)	63.0	No	Ramp Slope (%)	8.4
No	Ramp Width (in)	45.0	No	Ramp XSlope (%)	5.0
N/A	Flare Type LT	N/A	N/A	Flare Type RT	N/A
N/A	Flare Slope LT (%)	N/A	N/A	Flare Slope RT (%)	N/A
N/A	Flare Traversable LT?	N/A	N/A	Flare Traversable RT?	N/A
N/A	Landing Length (in)	N/A	N/A	DWS Provided?	N/A
N/A	Landing Width (in)	N/A	N/A	DWS Contrast?	N/A
N/A	Landing Slope (%)	N/A	N/A	DWS Length (in)	N/A
N/A	Landing X Slope (%)	N/A	N/A	DWS Full Width?	N/A
N/A	Landing Curb? (Y/N)	N/A	N/A	DWS Offset (in)	N/A
N/A	Shared Landing?	N/A			
N/A	Gutter Ponding?	N/A	N/A	Gutter Slope (%)	N/A
N/A	Gutter Lip Ht (in)	N/A	N/A	Gutter X Slope (%)	N/A
N/A	Painted X Walk1?	No	N/A	Painted X Walk2?	N/A
	X Walk 1 Direction	To NW		X Walk 2 Direction	N/A
N/A	X Walk 1 Width (in)	N/A	N/A	X Walk 2 Width (in)	N/A
	X Walk 1 Slope (%)	3.6		X Walk 2 Slope (%)	N/A
	X Walk 1 X Slope (%)	1.6		X Walk 2 X Slope (%)	N/A

N/A	Ramp inside XWalk1?	N/A	N/A	Ramp inside XWalk2?	N/A
	Road Slope (%)	1.6	N/A	Clear Space?	N/A
	Road X Slope (%)	3.6	N/A	Clear Space to XWalk (in)	N/A
N/A	Any Obstructions?	N/A	N/A	Storm Grate/Utility Hazard?	N/A
	Obstruction Type			Storm Grate/Utility Type	
		N/A			N/A
			Yes	Surface Condition? (G/P)	Good

Remove & Replace Entire Ramp.
