Access Compliance Report

Public Rights-of-Way

(Curb Ramps)

Intersection ID: 12979	Main Street: CENTRAL_AV	Cross Street: HEATH_CT	Location: NW
ADA ID: 84F5D8CC673C	Ramp Type: BlendTrans1	Initial Pass/Fail: Fail	Overall Compliance: No
		Severity Score: 10

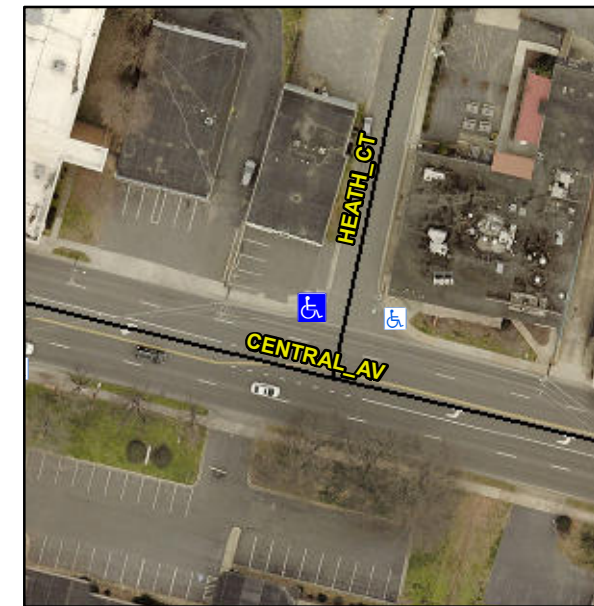
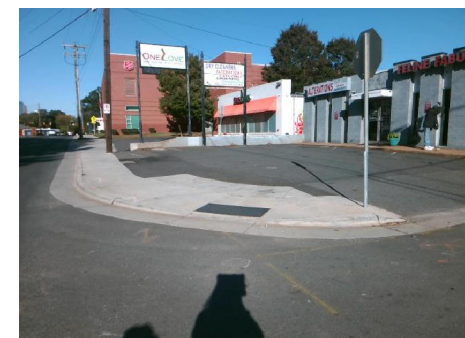
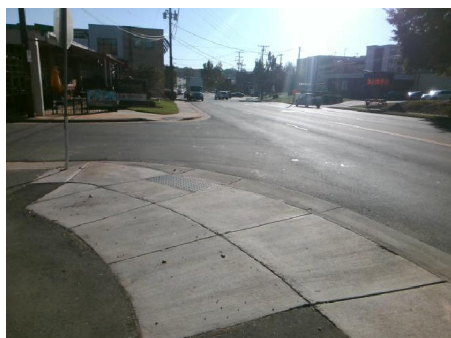
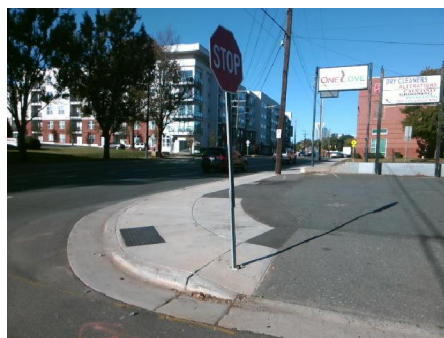
Not Found, R304.5.1, R304.5.3

Compliance	Description	Data	Compliance	Description	Data
N/A	Ramp Length (in)	60.5	Yes	BlendTrans Slope (%)	4.9
No	Ramp Width (in)	47.0	No	BlendTrans XSlope (%)	2.5
N/A	Flare Type LT	N/A	N/A	Flare Type RT	N/A
N/A	Flare Slope LT (%)	N/A	N/A	Flare Slope RT (%)	N/A
N/A	Flare Traversable LT?	N/A	N/A	Flare Traversable RT?	N/A
N/A	Landing Length (in)	N/A	N/A	DWS Provided?	N/A
N/A	Landing Width (in)	N/A	N/A	DWS Contrast?	N/A
N/A	Landing Slope (%)	N/A	N/A	DWS Length (in)	N/A
N/A	Landing X Slope (%)	N/A	N/A	DWS Full Width?	N/A
N/A	Landing Curb? (Y/N)	N/A	N/A	DWS Offset (in)	N/A
N/A	Shared Landing?	N/A			
N/A	Gutter Ponding?	N/A	N/A	Gutter Slope (%)	N/A
N/A	Gutter Lip Ht (in)	N/A	N/A	Gutter X Slope (%)	N/A
N/A	Painted X Walk1?	No	N/A	Painted X Walk2?	N/A
	X Walk 1 Direction	To E		X Walk 2 Direction	N/A
	X Walk 1 Width (in)	N/A		X Walk 2 Width (in)	N/A
	X Walk 1 Slope (%)	1.0		X Walk 2 Slope (%)	N/A
	X Walk 1 X Slope (%)	0.0		X Walk 2 X Slope (%)	N/A

N/A	Ramp inside XWalk1?	N/A	N/A	Ramp inside XWalk2?	N/A
	Road Slope (%)	0.0		Clear Space?	N/A
	Road X Slope (%)	1.0	N/A	Clear Space to XWalk (in)	N/A
N/A	Any Obstructions?	N/A	N/A	Storm Grate/Utility Hazard?	N/A
	Obstruction Type			Storm Grate/Utility Type	
		N/A			N/A
			Yes	Surface Condition? (G/P)	Good
			No	Curb Slope (%)	8.1

Remove & Replace Curb Ramp With Two New Directional Ramps or Equivalent.
