# Access Compliance Report

## Public Rights-of-Way

### (Curb Ramps)

| Intersection ID: 12220 | Main Street: E_6TH_ST | Cross Street: N_COLLEGE_ST | Location: W |

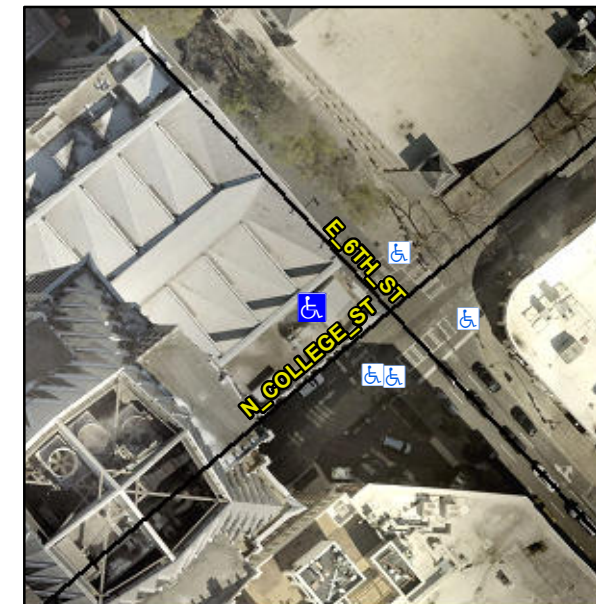
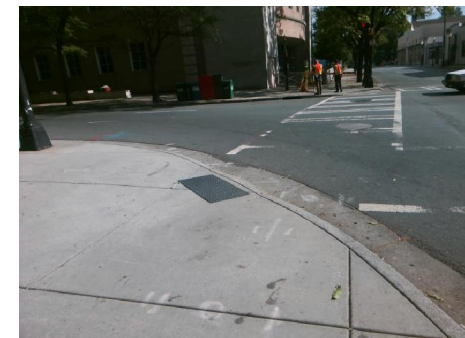
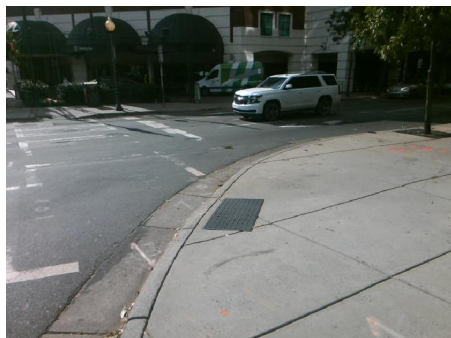
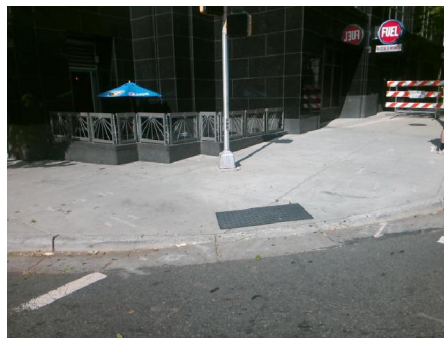
**Not Found, R304.5.3, R304.2.2-Perp, R304.3.2-Para, R305.2, R304.5.4**

| Compliance | Description | Data | Compliance | Description | Data |
|---|---|---|---|---|---|
| Yes | Ramp Width (in) | 48.0 | No | BlendTrans XSlope (%) | 4.8 |
| No | Landing Slope (%) | 3.1 | Yes | DWS Length (in) | 24.0 |
| No | Landing X Slope (%) | 4.2 | Yes | DWS Full Width? | Yes |
| N/A | Landing Curb? (Y/N) | No | No | DWS Offset (in) | 4.0 |
| Yes | Gutter Ponding? | No | No | Gutter Slope (%) | 6.5 |
| | | | No | Curb Slope (%) | 24.1 |

**Remove & Replace Curb Ramp With Two New Directional Ramps or Equivalent. Remove & Replace Gutter.**
