Access Compliance Report

Public Rights-of-Way

(Curb Ramps)

Intersection ID: 47114	Main Street: DIXON_BRANCH_LN	Cross Street: TINDLE_HILL_LN	Location: SE
ADA ID: 84FB4B6B2D8F	Ramp Type: PerpDiag	Initial Pass/Fail: Fail	Overall Compliance: No
		Severity Score: 8.75

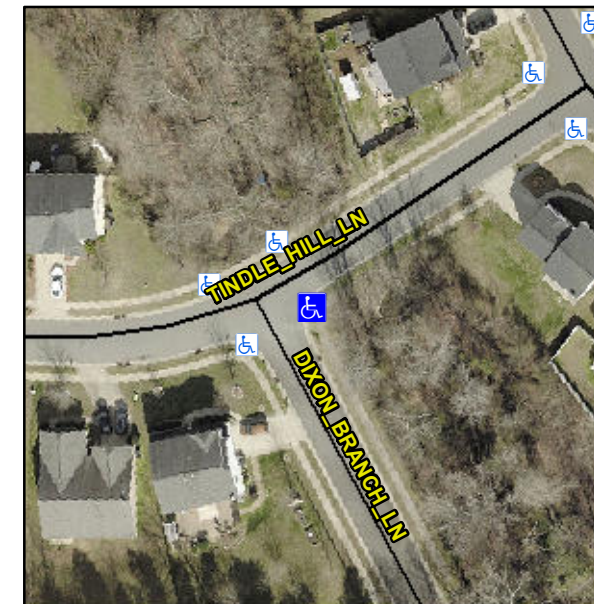
Not Found, R304.5.1

Compliance	Description	Data	Compliance	Description	Data
N/A	Ramp Length (in)	49.0	Yes	Ramp Slope (%)	6.8
No	Ramp Width (in)	47.0	Yes	Ramp XSlope (%)	1.2
N/A	Flare Type LT	N/A	N/A	Flare Type RT	N/A
N/A	Flare Slope LT (%)	N/A	N/A	Flare Slope RT (%)	N/A
N/A	Flare Traversable LT?	N/A	N/A	Flare Traversable RT?	N/A
N/A	Landing Length (in)	N/A	N/A	DWS Provided?	N/A
N/A	Landing Width (in)	N/A	N/A	DWS Contrast?	N/A
N/A	Landing Slope (%)	N/A	N/A	DWS Length (in)	N/A
N/A	Landing X Slope (%)	N/A	N/A	DWS Full Width?	N/A
N/A	Landing Curb? (Y/N)	N/A	N/A	DWS Offset (in)	N/A
N/A	Shared Landing?	N/A			
N/A	Gutter Ponding?	N/A	N/A	Gutter Slope (%)	N/A
N/A	Gutter Lip Ht (in)	N/A	N/A	Gutter X Slope (%)	N/A
N/A	Painted X Walk1?	No	N/A	Painted X Walk2?	No
	X Walk 1 Direction	To N		X Walk 2 Direction	To W
N/A	X Walk 1 Width (in)	N/A	N/A	X Walk 2 Width (in)	N/A
	X Walk 1 Slope (%)	0.9		X Walk 2 Slope (%)	4.0
	X Walk 1 X Slope (%)	1.8		X Walk 2 X Slope (%)	0.3

N/A	Ramp inside XWalk1?	N/A	N/A	Ramp inside XWalk2?	N/A
	Road Slope (%)	1.5	N/A	Clear Space?	N/A
	Road X Slope (%)	0.7	N/A	Clear Space to XWalk (in)	N/A
N/A	Any Obstructions?	N/A	N/A	Storm Grate/Utility Hazard?	N/A
	Obstruction Type			Storm Grate/Utility Type	
		N/A			N/A
		Yes		Surface Condition? (G/P)	Good

Remove & Replace Curb Ramp With Two New Directional Ramps or Equivalent.

Total Cost: \$ 3200.00
