Access Compliance Report Public Rights-of-Way (Curb Ramps)

Intersection ID: 11610 Main Street: COLE_DR Cross Street: GLENVILLE_AV Location: SW

ADA ID: 84FE165532AD Ramp Type: PerpDiag Initial Pass/Fail: Fail Overall Compliance: No Severity Score: 13.75

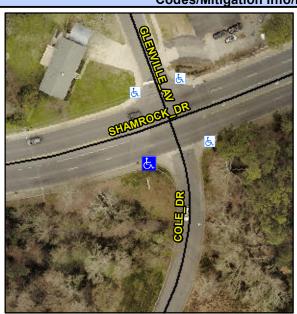
Not Found, R304.2.2, R304.5.3

Compliance Description D		Data	Comp	iance Descriptio	n Data
N/A	Ramp Length (in)	59.5	No	Ramp Slope (%)	9.3
Yes	Ramp Width (in)	48.0	No	Ramp XSlope (%	3.1
N/A	Flare Type LT	N/A	N/A	Flare Type RT	N/A
N/A	Flare Slope LT (%)	N/A	N/A	Flare Slope RT (%	%) N/A
N/A	Flare Traversable LT?	N/A	N/A	Flare Traversable	RT? N/A
N/A	Landing Length (in)	N/A	N/A	DWS Provided?	N/A
N/A	Landing Width (in)	N/A	N/A	DWS Contrast?	N/A
N/A	Landing Slope (%)	N/A	N/A	DWS Length (in)	N/A
N/A	Landing X Slope (%)	N/A	N/A	DWS Full Width?	N/A
N/A	Landing Curb? (Y/N)	N/A	N/A	DWS Offset (in)	N/A
N/A	Shared Landing?	N/A			
N/A	Gutter Ponding?	N/A	N/A	Gutter Slope (%)	N/A
N/A	Gutter Lip Ht (in)	N/A	N/A	Gutter X Slope (%	%) N/A
N/A	Painted X Walk1?	No	N/A	Painted X Walk2?	No
	X Walk 1 Direction	To E		X Walk 2 Direction	n To N
N/A	X Walk 1 Width (in)	N/A	N/A	X Walk 2 Width (i	n) N/A
	X Walk 1 Slope (%)	2.9		X Walk 2 Slope (9	%) 1.8
	X Walk 1 X Slope (%)	0.4		X Walk 2 X Slope	(%) 3.2

N/A	Ramp inside XWalk1?	N/A	N/A	Ramp inside XWa	alk2? N/A
	Road Slope (%)	4.2	N/A	Clear Space?	N/A
	Road X Slope (%)	3.1	N/A	Clear Space to X	Walk (in) N/A
N/A	Any Obstructions?	N/A	N/A	Storm Grate/Utilit	y Hazard? N/A
	Obstruction Type			Storm Grate/Utilit	у Туре
		N/A			N/A

Remove & Replace Curb Ramp With Two New Directional Ramps or Equivalent.

Total Cost: \$ 3200.00
