## Access Compliance Report Public Rights-of-Way (Curb Ramps)

Intersection ID: 10037302Main Street: SARDIS\_RDCross Street: N/ALocation:NEADA ID: 8501665F9CABRamp Type: BlendTrans2Initial Pass/Fail: FailOverall Compliance: NoSeverity Score: 12.5

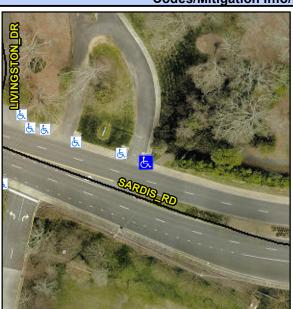
Not Found, R304.5.3

Comp	liance Description	Data	Comp	liance Description	Data
N/A	Ramp Length (in)	60.0	Yes	BlendTrans Slope (%)	1.1
Yes	Ramp Width (in)	48.0	No	BlendTrans XSlope (%)	6.1
N/A	Flare Type LT	N/A	N/A	Flare Type RT	N/A
N/A	Flare Slope LT (%)	N/A	N/A	Flare Slope RT (%)	N/A
N/A	Flare Traversable LT?	N/A	N/A	Flare Traversable RT?	N/A
N/A	Landing Length (in)	N/A	N/A	DWS Provided?	N/A
N/A	Landing Width (in)	N/A	N/A	DWS Contrast?	N/A
N/A	Landing Slope (%)	N/A	N/A	DWS Length (in)	N/A
N/A	Landing X Slope (%)	N/A	N/A	DWS Full Width?	N/A
N/A	Landing Curb? (Y/N)	N/A	N/A	DWS Offset (in)	N/A
N/A	Shared Landing?	N/A			
N/A	Gutter Ponding?	N/A	N/A	Gutter Slope (%)	N/A
N/A	Gutter Lip Ht (in)	N/A	N/A	Gutter X Slope (%)	N/A
N/A	Painted X Walk1?	No	N/A	Painted X Walk2?	N/A
	X Walk 1 Direction	To NW		X Walk 2 Direction	N/A
	X Walk 1 Width (in)	N/A		X Walk 2 Width (in)	N/A
	X Walk 1 Slope (%)	0.8		X Walk 2 Slope (%)	N/A
	X Walk 1 X Slope (%)	3.7		X Walk 2 X Slope (%)	N/A

N/A	Ramp inside XWalk1?	N/A	N/A	Ramp inside XWalk2?	N/A
	Road Slope (%)	3.7		Clear Space?	N/A
	Road X Slope (%)	0.8	N/A	Clear Space to XWalk (in)	N/A
N/A	Any Obstructions?	N/A	N/A	Storm Grate/Utility Hazard?	N/A
	Obstruction Type			Storm Grate/Utility Type	
		N/A			N/A
			Yes	Surface Condition? (G/P)	Good
	The second second		No	Curb Slope (%)	8.0

Remove & Replace Curb Ramp With Two New Directional Ramps or Equivalent.
