# Access Compliance Report

## Public Rights-of-Way

### (Curb Ramps)

Intersection ID: N/A	Main Street: DIXIE_RIVER_RD	Cross Street: N/A	Location: N
ADA ID: 85066D4DD153	Ramp Type: PerpDiag	Initial Pass/Fail: Fail	Overall Compliance: No
		Severity Score: 30

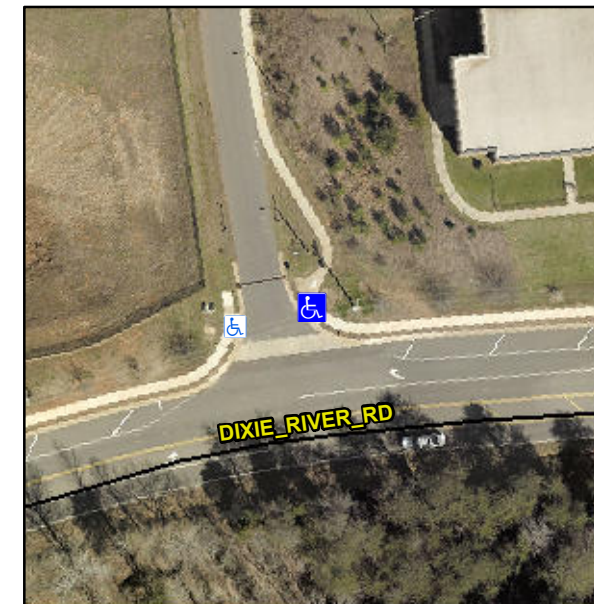
**Not Found, R304.5.1, R304.2.2**

Compliance	Description	Data	Compliance	Description	Data
N/A	Ramp Length (in)	96.0	No	Ramp Slope (%)	9.3
No	Ramp Width (in)	35.0	Yes	Ramp XSlope (%)	1.1
N/A	Flare Type LT	N/A	N/A	Flare Type RT	N/A
N/A	Flare Slope LT (%)	N/A	N/A	Flare Slope RT (%)	N/A
N/A	Flare Traversable LT?	N/A	N/A	Flare Traversable RT?	N/A
N/A	Landing Length (in)	N/A	N/A	DWS Provided?	N/A
N/A	Landing Width (in)	N/A	N/A	DWS Contrast?	N/A
N/A	Landing Slope (%)	N/A	N/A	DWS Length (in)	N/A
N/A	Landing X Slope (%)	N/A	N/A	DWS Full Width?	N/A
N/A	Landing Curb? (Y/N)	N/A	N/A	DWS Offset (in)	N/A
N/A	Shared Landing?	N/A			
N/A	Gutter Ponding?	N/A	N/A	Gutter Slope (%)	N/A
N/A	Gutter Lip Ht (in)	N/A	N/A	Gutter X Slope (%)	N/A
N/A	Painted X Walk1?	No	N/A	Painted X Walk2?	No
	X Walk 1 Direction	To W		X Walk 2 Direction	To S
N/A	X Walk 1 Width (in)	N/A	N/A	X Walk 2 Width (in)	N/A
	X Walk 1 Slope (%)	2.6		X Walk 2 Slope (%)	0.6
	X Walk 1 X Slope (%)	1.1		X Walk 2 X Slope (%)	2.9

N/A	Ramp inside XWalk1?	N/A	N/A	Ramp inside XWalk2?	N/A
	Road Slope (%)	1.4	N/A	Clear Space?	N/A
	Road X Slope (%)	3.1	N/A	Clear Space to XWalk (in)	N/A
N/A	Any Obstructions?	N/A	N/A	Storm Grate/Utility Hazard?	N/A
	Obstruction Type			Storm Grate/Utility Type	
		N/A			N/A
			Yes	Surface Condition? (G/P)	Good

**Remove & Replace Curb Ramp With Two New Directional Ramps or Equivalent.**
