Access Compliance Report

Public Rights-of-Way

Intersection ID: N/A	Main Street: S_COLLEGE_ST	Cross Street: E_3RD_ST	Location: E
ADA ID: 850DE7125917	Ramp Type: PerpDiag	Initial Pass/Fail: Fail	Overall Compliance: No
Severity Score: 25			
Codes/Mitigation Info/Possible Solution		Field Measurements/Component Compliance

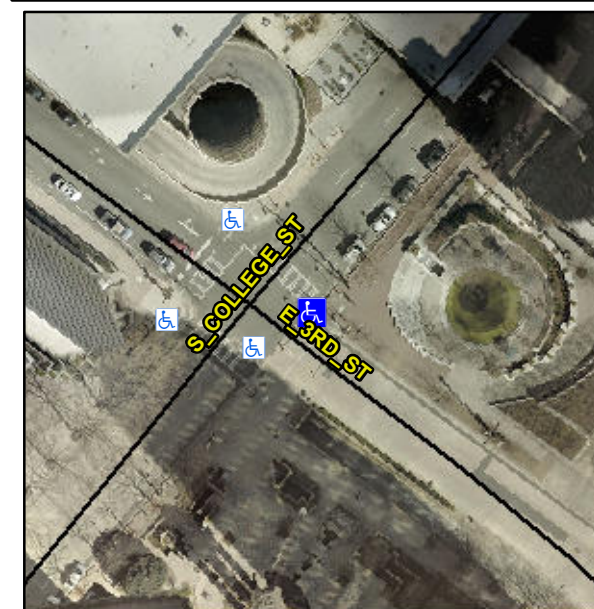
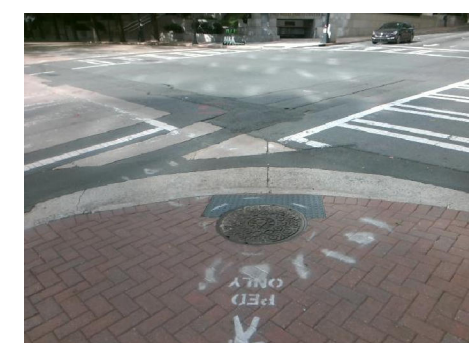
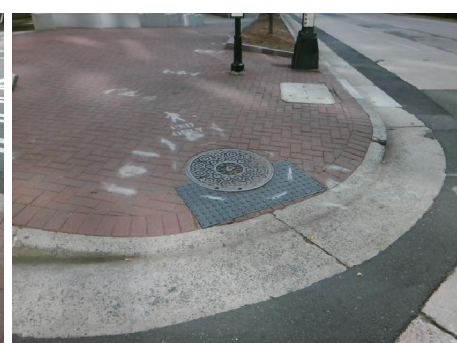
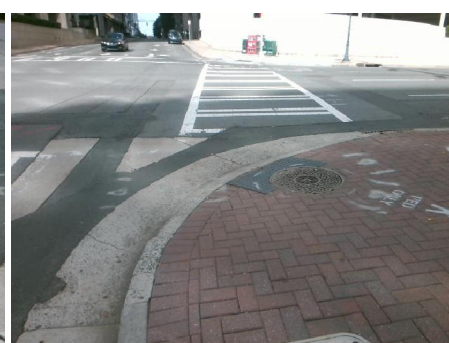
Not Found, R304.5.3

Compliance	Description	Data	Compliance	Description	Data
N/A	Ramp Length (in)	70.0	Yes	Ramp Slope (%)	7.4
Yes	Ramp Width (in)	75.0	No	Ramp XSlope (%)	7.7
N/A	Flare Type LT	N/A	N/A	Flare Type RT	N/A
N/A	Flare Slope LT (%)	N/A	N/A	Flare Slope RT (%)	N/A
N/A	Flare Traversable LT?	N/A	N/A	Flare Traversable RT?	N/A
N/A	Landing Length (in)	N/A	N/A	DWS Provided?	N/A
N/A	Landing Width (in)	N/A	N/A	DWS Contrast?	N/A
N/A	Landing Slope (%)	N/A	N/A	DWS Length (in)	N/A
N/A	Landing X Slope (%)	N/A	N/A	DWS Full Width?	N/A
N/A	Landing Curb? (Y/N)	N/A	N/A	DWS Offset (in)	N/A
N/A	Shared Landing?	N/A			
N/A	Gutter Ponding?	N/A	N/A	Gutter Slope (%)	N/A
N/A	Gutter Lip Ht (in)	N/A	N/A	Gutter X Slope (%)	N/A
N/A	Painted X Walk1?	Yes	N/A	Painted X Walk2?	Yes
	X Walk 1 Direction	To NW		X Walk 2 Direction	To SW
N/A	X Walk 1 Width (in)	109.0	N/A	X Walk 2 Width (in)	114.0
	X Walk 1 Slope (%)	5.3		X Walk 2 Slope (%)	1.3
	X Walk 1 X Slope (%)	0.2		X Walk 2 X Slope (%)	5.6

N/A	Ramp inside XWalk1?	Yes	N/A	Ramp inside XWalk2?	Yes
	Road Slope (%)	6.4	N/A	Clear Space?	N/A
	Road X Slope (%)	8.4	N/A	Clear Space to XWalk (in)	N/A
N/A	Any Obstructions?	N/A	N/A	Storm Grate/Utility Hazard?	N/A
	Obstruction Type			Storm Grate/Utility Type	
		N/A			N/A
		Yes		Surface Condition? (G/P)	Good

Remove & Replace Curb Ramp With Two New Directional Ramps or Equivalent.

Total Cost: \$ 3200.00
