# Access Compliance Report

## Public Rights-of-Way

### (Curb Ramps)

Intersection ID: 13404	Main Street: LEXINGTON_AV	Cross Street: E_CARSON_BV	Location: SE
ADA ID: 850E7F2547F2	Ramp Type: BlendTrans2	Initial Pass/Fail: Fail	Overall Compliance: No
		Severity Score: 10

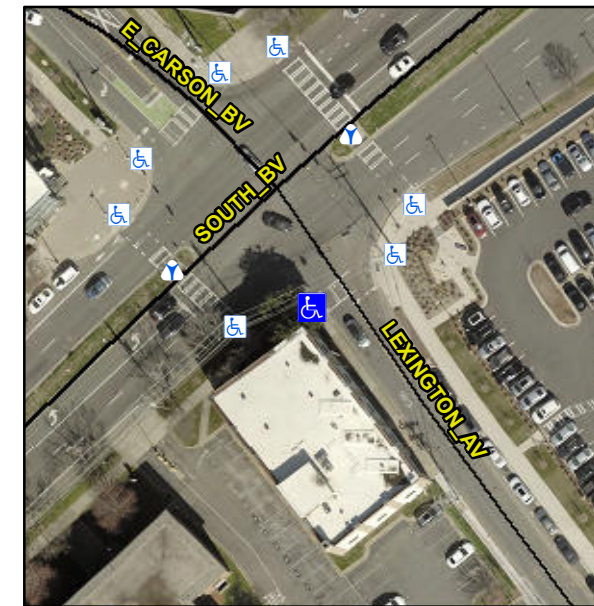
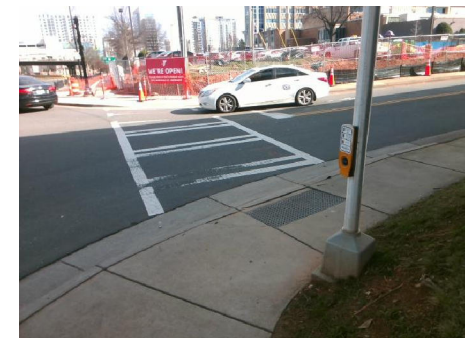
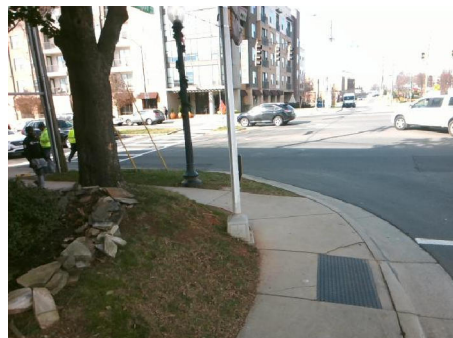
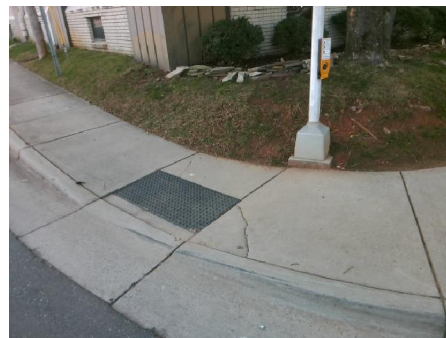
**Not Found, R304.5.1**

Compliance	Description	Data	Compliance	Description	Data
N/A	Ramp Length (in)	56.0	Yes	BlendTrans Slope (%)	0.9
No	Ramp Width (in)	47.0	Yes	BlendTrans XSlope (%)	3.9
N/A	Flare Type LT	N/A	N/A	Flare Type RT	N/A
N/A	Flare Slope LT (%)	N/A	N/A	Flare Slope RT (%)	N/A
N/A	Flare Traversable LT?	N/A	N/A	Flare Traversable RT?	N/A
N/A	Landing Length (in)	N/A	N/A	DWS Provided?	N/A
N/A	Landing Width (in)	N/A	N/A	DWS Contrast?	N/A
N/A	Landing Slope (%)	N/A	N/A	DWS Length (in)	N/A
N/A	Landing X Slope (%)	N/A	N/A	DWS Full Width?	N/A
N/A	Landing Curb? (Y/N)	N/A	N/A	DWS Offset (in)	N/A
N/A	Shared Landing?	N/A			
N/A	Gutter Ponding?	N/A	N/A	Gutter Slope (%)	N/A
N/A	Gutter Lip Ht (in)	N/A	N/A	Gutter X Slope (%)	N/A
N/A	Painted X Walk1?	Yes	N/A	Painted X Walk2?	N/A
	X Walk 1 Direction	To NE		X Walk 2 Direction	N/A
	X Walk 1 Width (in)	112.0		X Walk 2 Width (in)	N/A
	X Walk 1 Slope (%)	2.6		X Walk 2 Slope (%)	N/A
	X Walk 1 X Slope (%)	4.9		X Walk 2 X Slope (%)	N/A

N/A	Ramp inside XWalk1?	Yes	N/A	Ramp inside XWalk2?	N/A
	Road Slope (%)	4.9		Clear Space?	N/A
	Road X Slope (%)	2.6	N/A	Clear Space to XWalk (in)	N/A
N/A	Any Obstructions?	N/A	N/A	Storm Grate/Utility Hazard?	N/A
	Obstruction Type			Storm Grate/Utility Type	
		N/A			N/A
			Yes	Surface Condition? (G/P)	Good
			No	Curb Slope (%)	7.9

**Remove & Replace Curb Ramp With Two New Directional Ramps or Equivalent.**
