Access Compliance Report

Public Rights-of-Way

(Curb Ramps)

Intersection ID: 10624	Main Street: STATE_ST	Cross Street: SUMTER_AV	Location: SE
ADA ID: 8519CCDF80AB	Ramp Type: BlendTrans1	Initial Pass/Fail: Fail	Overall Compliance: No
		Severity Score: 10

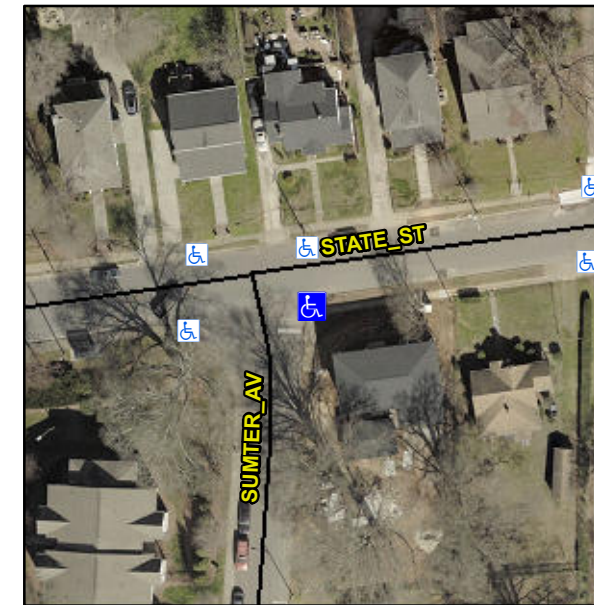
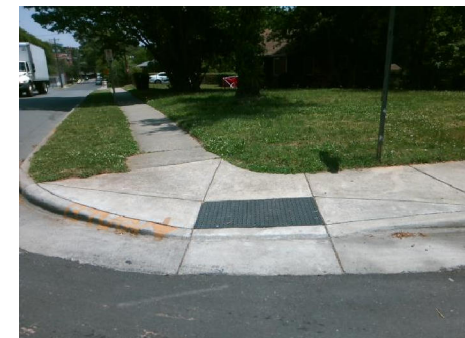
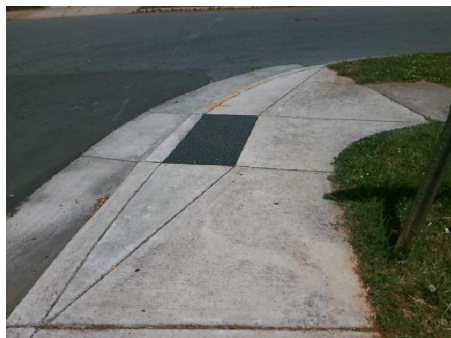
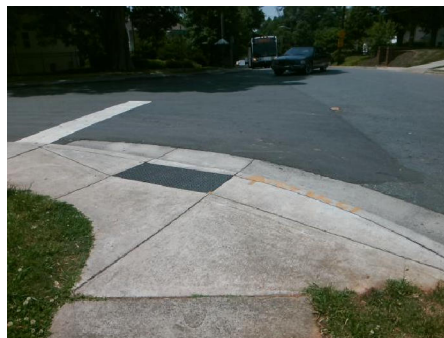
Not Found, R304.5.1, R304.5.3

Compliance	Description	Data	Compliance	Description	Data
N/A	Ramp Length (in)	55.0	Yes	BlendTrans Slope (%)	4.0
No	Ramp Width (in)	47.0	No	BlendTrans XSlope (%)	2.2
N/A	Flare Type LT	N/A	N/A	Flare Type RT	N/A
N/A	Flare Slope LT (%)	N/A	N/A	Flare Slope RT (%)	N/A
N/A	Flare Traversable LT?	N/A	N/A	Flare Traversable RT?	N/A
N/A	Landing Length (in)	N/A	N/A	DWS Provided?	N/A
N/A	Landing Width (in)	N/A	N/A	DWS Contrast?	N/A
N/A	Landing Slope (%)	N/A	N/A	DWS Length (in)	N/A
N/A	Landing X Slope (%)	N/A	N/A	DWS Full Width?	N/A
N/A	Landing Curb? (Y/N)	N/A	N/A	DWS Offset (in)	N/A
N/A	Shared Landing?	N/A			
N/A	Gutter Ponding?	N/A	N/A	Gutter Slope (%)	N/A
N/A	Gutter Lip Ht (in)	N/A	N/A	Gutter X Slope (%)	N/A
N/A	Painted X Walk1?	No	N/A	Painted X Walk2?	No
	X Walk 1 Direction	To N		X Walk 2 Direction	To W
	X Walk 1 Width (in)	N/A		X Walk 2 Width (in)	N/A
	X Walk 1 Slope (%)	1.4		X Walk 2 Slope (%)	1.6
	X Walk 1 X Slope (%)	4.4		X Walk 2 X Slope (%)	1.1

N/A	Ramp inside XWalk1?	N/A	N/A	Ramp inside XWalk2?	N/A
	Road Slope (%)	0.2		Clear Space?	N/A
	Road X Slope (%)	2.8	N/A	Clear Space to XWalk (in)	N/A
N/A	Any Obstructions?	N/A	N/A	Storm Grate/Utility Hazard?	N/A
	Obstruction Type			Storm Grate/Utility Type	
		N/A			N/A
			Yes	Surface Condition? (G/P)	Good
			No	Curb Slope (%)	8.6

Remove & Replace Curb Ramp With Two New Directional Ramps or Equivalent.
