Access Compliance Report Public Rights-of-Way (Curb Ramps)

Intersection ID: 2868 Main Street: BELL'S MILL DR **Cross Street: TAYMOUTH LN** Location:

ADA ID: 851C941DEAA7 Ramp Type: PerpDiag Initial Pass/Fail: Pass **Overall Compliance: No** Severity Score: 17.75

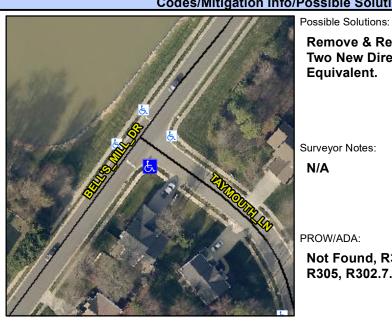
1 leid Measurements/Component Compilance					
	liance Description	Data		Diance Description	Data
N/A	Ramp Length (in)	48.0	Yes	Ramp Slope (%)	6.0
Yes	Ramp Width (in)	48.0	No	Ramp XSlope (%)	3.7
N/A	Flare Type LT	Sloped	N/A	Flare Type RT	N/A
N/A	Flare Slope LT (%)	3.9	N/A	Flare Slope RT (%)	11.6
N/A	Flare Traversable LT?	No	N/A	Flare Traversable RT?	No
Yes	Landing Length (in)	50.0	No	DWS Provided?	No
No	Landing Width (in)	22.0	N/A	DWS Contrast?	No
Yes	Landing Slope (%)	0.5	N/A	DWS Length (in)	N/A
No	Landing X Slope (%)	3.1	N/A	DWS Full Width?	No
N/A	Landing Curb? (Y/N)	No	N/A	DWS Offset (in)	N/A
N/A	Shared Landing?	No			
Yes	Gutter Ponding?	No	Yes	Gutter Slope (%)	0.6
No	Gutter Lip Ht (in)	0.5	Yes	Gutter X Slope (%)	1.8
N/A	Painted X Walk1?	No	N/A	Painted X Walk2?	No
	X Walk 1 Direction	To NE		X Walk 2 Direction	To NW
N/A	X Walk 1 Width (in)	N/A	N/A	X Walk 2 Width (in)	N/A
	X Walk 1 Slope (%)	2.0		X Walk 2 Slope (%)	4.8

X Walk 1 X Slope (%)	3.1		X Walk 2 X Slope (%)	2.1
N/A	Ramp inside XWalk1?	N/A	N/A	Ramp inside XWalk2?	N/A
	Road Slope (%)	0.4	N/A	Clear Space?	Yes
	Road X Slope (%)	3.3	N/A	Clear Space to XWalk (in)	N/A
Yes	Any Obstructions?	No	Yes	Storm Grate/Utility Hazard?	No
	Obstruction Type			Storm Grate/Utility Type	
		N/A			N/A
			I

TAYMOUTH LN StopSign **BELL'S MILL DR** StopSign Remove & Replace Curb Ramp With Two New Directional Ramps or Equivalent.

Not Found, R304.5.3, R304.2.1, R305, R302.7.2

Total Cost:	\$ 3200.00
