Access Compliance Report Public Rights-of-Way (Curb Ramps)

Intersection ID: 25654	Main Street: REA_RD	Cross Street: STALLWORTH_DR	Location: SW
ADA ID: 851DECBE1EAB	Ramp Type: PerpDiag	Initial Pass/Fail: Fail	Overall Compliance: No Severity Score: 10

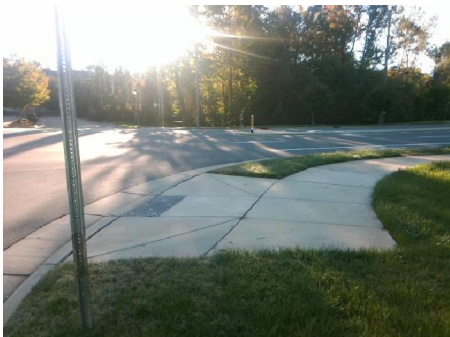
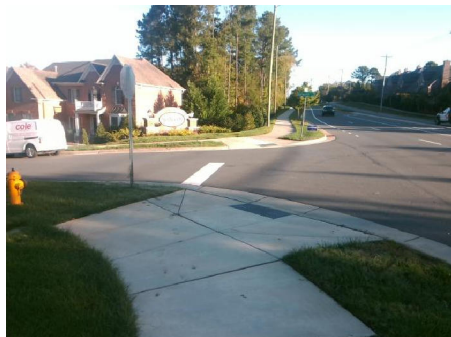
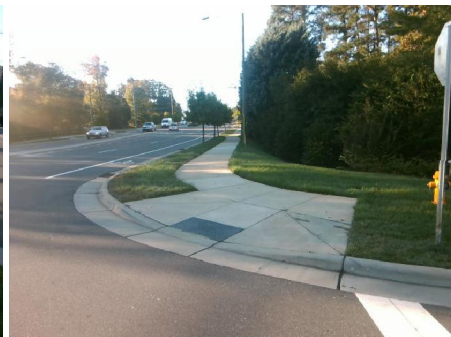
Not Found, R304.5.1, R304.5.3

Compliance	Description	Data	Compliance	Description	Data
N/A	Ramp Length (in)	74.0	Yes	Ramp Slope (%)	6.8
No	Ramp Width (in)	46.0	No	Ramp XSlope (%)	2.2
N/A	Flare Type LT	N/A	N/A	Flare Type RT	N/A
N/A	Flare Slope LT (%)	N/A	N/A	Flare Slope RT (%)	N/A
N/A	Flare Traversable LT?	N/A	N/A	Flare Traversable RT?	N/A
N/A	Landing Length (in)	N/A	N/A	DWS Provided?	N/A
N/A	Landing Width (in)	N/A	N/A	DWS Contrast?	N/A
N/A	Landing Slope (%)	N/A	N/A	DWS Length (in)	N/A
N/A	Landing X Slope (%)	N/A	N/A	DWS Full Width?	N/A
N/A	Landing Curb? (Y/N)	N/A	N/A	DWS Offset (in)	N/A
N/A	Shared Landing?	N/A			
N/A	Gutter Ponding?	N/A	N/A	Gutter Slope (%)	N/A
N/A	Gutter Lip Ht (in)	N/A	N/A	Gutter X Slope (%)	N/A
N/A	Painted X Walk1?	No	N/A	Painted X Walk2?	No
	X Walk 1 Direction	To E		X Walk 2 Direction	To N
N/A	X Walk 1 Width (in)	N/A	N/A	X Walk 2 Width (in)	N/A
	X Walk 1 Slope (%)	3.1		X Walk 2 Slope (%)	0.6
	X Walk 1 X Slope (%)	0.2		X Walk 2 X Slope (%)	3.6

N/A	Ramp inside XWalk1?	N/A	N/A	Ramp inside XWalk2?	N/A
	Road Slope (%)	2.1	N/A	Clear Space?	N/A
	Road X Slope (%)	2.6	N/A	Clear Space to XWalk (in)	N/A
N/A	Any Obstructions?	N/A	N/A	Storm Grate/Utility Hazard?	N/A
	Obstruction Type			Storm Grate/Utility Type	
		N/A			N/A
			Yes	Surface Condition? (G/P)	Good

Possible Solutions:
Remove & Replace Curb Ramp With Two New Directional Ramps or Equivalent.
