Access Compliance Report

Public Rights-of-Way

(Curb Ramps)

Intersection ID: 10777	Main Street: WESLEY_AV	Cross Street: WHITING_AV	Location: E
ADA ID: 8534C91DB654	Ramp Type: Perp	Initial Pass/Fail: Fail	Overall Compliance: No
Severity Score: 12.5			
Codes/Mitigation Info/Possible Solution		Field Measurements/Component Compliance

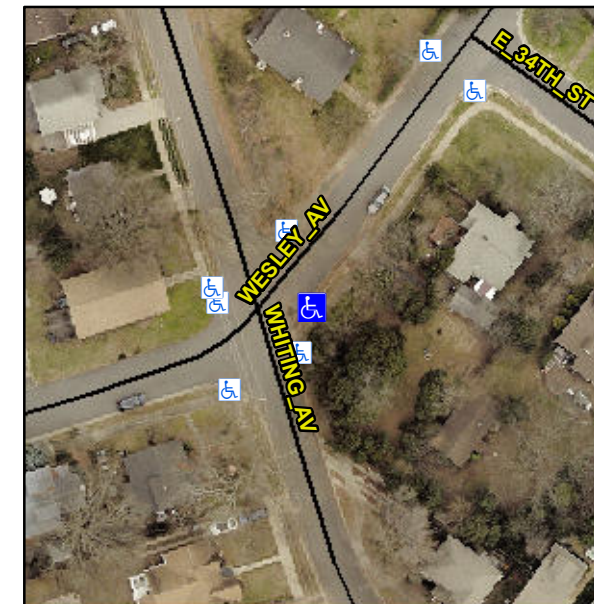
Compliance	Description	Data	Compliance	Description	Data
N/A	Ramp Length (in)	48.0	No	Ramp Slope (%)	11.4
Yes	Ramp Width (in)	48.0	Yes	Ramp XSlope (%)	0.0
N/A	Flare Type LT	N/A	N/A	Flare Type RT	N/A
N/A	Flare Slope LT (%)	N/A	N/A	Flare Slope RT (%)	N/A
N/A	Flare Traversable LT?	N/A	N/A	Flare Traversable RT?	N/A
N/A	Landing Length (in)	N/A	N/A	DWS Provided?	N/A
N/A	Landing Width (in)	N/A	N/A	DWS Contrast?	N/A
N/A	Landing Slope (%)	N/A	N/A	DWS Length (in)	N/A
N/A	Landing X Slope (%)	N/A	N/A	DWS Full Width?	N/A
N/A	Landing Curb? (Y/N)	N/A	N/A	DWS Offset (in)	N/A
N/A	Shared Landing?	N/A			
N/A	Gutter Ponding?	N/A	N/A	Gutter Slope (%)	N/A
N/A	Gutter Lip Ht (in)	N/A	N/A	Gutter X Slope (%)	N/A
N/A	Painted X Walk1?	No	N/A	Painted X Walk2?	N/A
	X Walk 1 Direction	To N		X Walk 2 Direction	N/A
N/A	X Walk 1 Width (in)	N/A	N/A	X Walk 2 Width (in)	N/A
	X Walk 1 Slope (%)	0.3		X Walk 2 Slope (%)	N/A
	X Walk 1 X Slope (%)	1.2		X Walk 2 X Slope (%)	N/A

N/A	Ramp inside XWalk1?	N/A	N/A	Ramp inside XWalk2?	N/A
	Road Slope (%)	N/A	N/A	Clear Space?	N/A
	Road X Slope (%)	N/A	N/A	Clear Space to XWalk (in)	N/A
N/A	Any Obstructions?	N/A	N/A	Storm Grate/Utility Hazard?	N/A
	Obstruction Type			Storm Grate/Utility Type	
		N/A			N/A
			Yes	Surface Condition? (G/P)	Good

Possible Solutions:

Remove & Replace Entire Ramp.
