Access Compliance Report

Public Rights-of-Way

(Curb Ramps)

Intersection ID: 29960	Main Street: CANIPE_DR	Cross Street: DAVIS_CROSSING_CT	Location: W
ADA ID: 8538DE14C9C7	Ramp Type: Perp	Initial Pass/Fail: Fail	Overall Compliance: No
Severity Score: 26.25			
Codes/Mitigation Info/Possible Solution		Field Measurements/Component Compliance

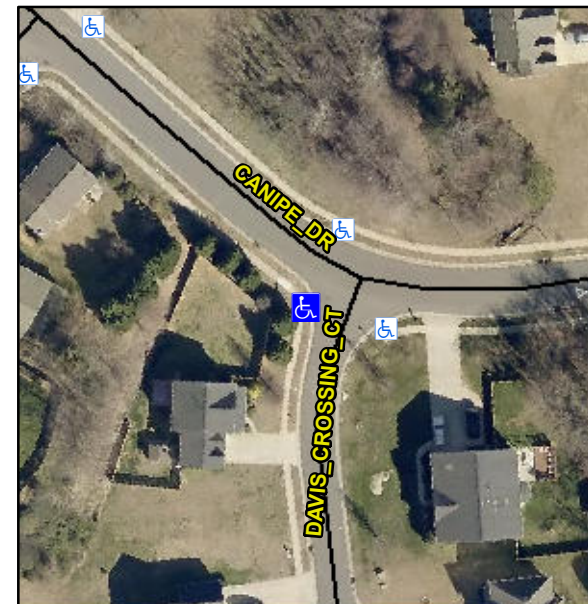
Not Found, R304.2.2, R304.5.3

Compliance	Description	Data	Compliance	Description	Data
N/A	Ramp Length (in)	48.0	No	Ramp Slope (%)	13.7
Yes	Ramp Width (in)	48.0	No	Ramp XSlope (%)	2.8
N/A	Flare Type LT	N/A	N/A	Flare Type RT	N/A
N/A	Flare Slope LT (%)	N/A	N/A	Flare Slope RT (%)	N/A
N/A	Flare Traversable LT?	N/A	N/A	Flare Traversable RT?	N/A
N/A	Landing Length (in)	N/A	N/A	DWS Provided?	N/A
N/A	Landing Width (in)	N/A	N/A	DWS Contrast?	N/A
N/A	Landing Slope (%)	N/A	N/A	DWS Length (in)	N/A
N/A	Landing X Slope (%)	N/A	N/A	DWS Full Width?	N/A
N/A	Landing Curb? (Y/N)	N/A	N/A	DWS Offset (in)	N/A
N/A	Shared Landing?	N/A			
N/A	Gutter Ponding?	N/A	N/A	Gutter Slope (%)	N/A
N/A	Gutter Lip Ht (in)	N/A	N/A	Gutter X Slope (%)	N/A
N/A	Painted X Walk1?	No	N/A	Painted X Walk2?	N/A
	X Walk 1 Direction	To SE		X Walk 2 Direction	N/A
N/A	X Walk 1 Width (in)	N/A	N/A	X Walk 2 Width (in)	N/A
	X Walk 1 Slope (%)	2.9		X Walk 2 Slope (%)	N/A
	X Walk 1 X Slope (%)	3.0		X Walk 2 X Slope (%)	N/A

N/A	Ramp inside XWalk1?	N/A	N/A	Ramp inside XWalk2?	N/A
	Road Slope (%)	N/A	N/A	Clear Space?	N/A
	Road X Slope (%)	N/A	N/A	Clear Space to XWalk (in)	N/A
N/A	Any Obstructions?	N/A	N/A	Storm Grate/Utility Hazard?	N/A
	Obstruction Type			Storm Grate/Utility Type	
		N/A			N/A
			Yes	Surface Condition? (G/P)	Good

Possible Solutions:

Remove & Replace Entire Ramp.

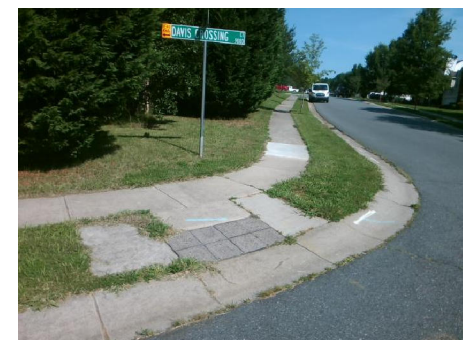
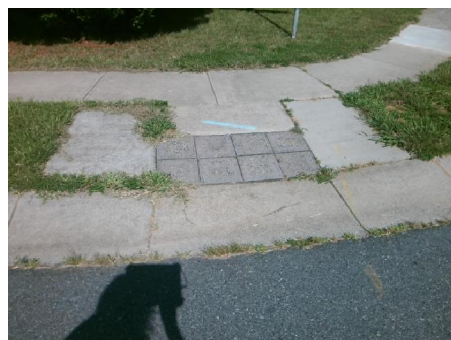
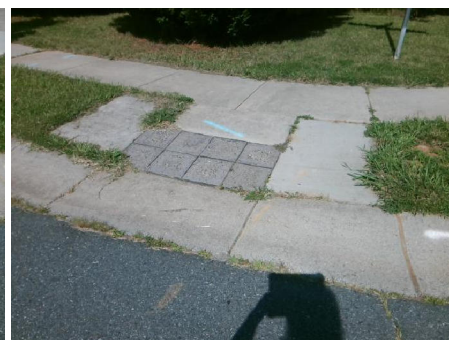
Street 1 Name DAVIS CROSSING CT

Stop Condition-Street 2 StopSign
