Access Compliance Report

Public Rights-of-Way

(Curb Ramps)

Intersection ID: 11671	Main Street: PARKWOOD_AV	Cross Street: N_CALDWELL_ST	Location: S
ADA ID: 854132EDB45F	Ramp Type: Perp	Initial Pass/Fail: Fail	Overall Compliance: No
Codes/Mitigation Info/Possible Solution		Field Measurements/Component Compliance	
Severity Score: 13.75

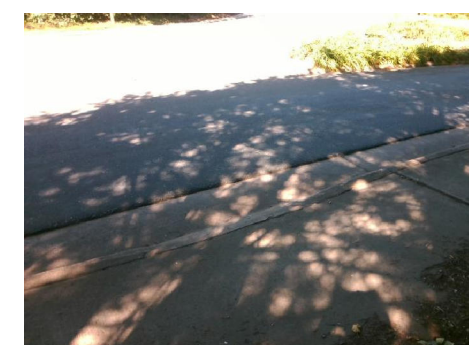
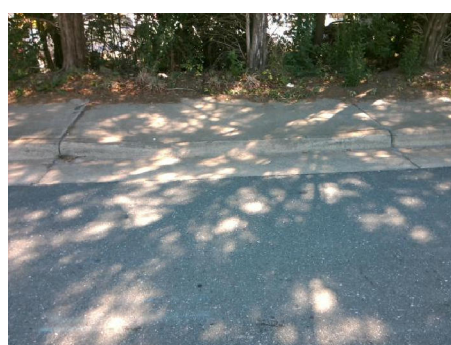
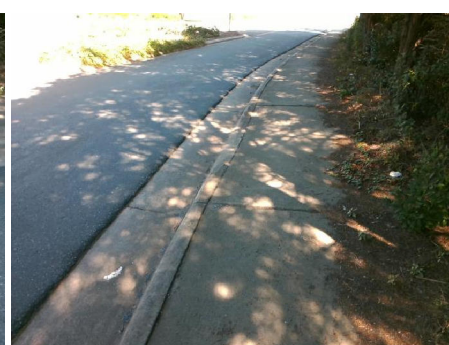
Not Found, R304.2.2

Compliance	Description	Data	Compliance	Description	Data
N/A	Ramp Length (in)	61.0	No	Ramp Slope (%)	8.8
Yes	Ramp Width (in)	48.0	Yes	Ramp XSlope (%)	3.3
N/A	Flare Type LT	N/A	N/A	Flare Type RT	N/A
N/A	Flare Slope LT (%)	N/A	N/A	Flare Slope RT (%)	N/A
N/A	Flare Traversable LT?	N/A	N/A	Flare Traversable RT?	N/A
N/A	Landing Length (in)	N/A	N/A	DWS Provided?	N/A
N/A	Landing Width (in)	N/A	N/A	DWS Contrast?	N/A
N/A	Landing Slope (%)	N/A	N/A	DWS Length (in)	N/A
N/A	Landing X Slope (%)	N/A	N/A	DWS Full Width?	N/A
N/A	Landing Curb? (Y/N)	N/A	N/A	DWS Offset (in)	N/A
N/A	Shared Landing?	N/A			
N/A	Gutter Ponding?	N/A	N/A	Gutter Slope (%)	N/A
N/A	Gutter Lip Ht (in)	N/A	N/A	Gutter X Slope (%)	N/A
N/A	Painted X Walk1?	No	N/A	Painted X Walk2?	N/A
	X Walk 1 Direction	To N		X Walk 2 Direction	N/A
N/A	X Walk 1 Width (in)	N/A	N/A	X Walk 2 Width (in)	N/A
	X Walk 1 Slope (%)	3.2		X Walk 2 Slope (%)	N/A
	X Walk 1 X Slope (%)	4.3		X Walk 2 X Slope (%)	N/A

N/A	Ramp inside XWalk1?	N/A	N/A	Ramp inside XWalk2?	N/A
	Road Slope (%)	N/A	N/A	Clear Space?	N/A
	Road X Slope (%)	N/A	N/A	Clear Space to XWalk (in)	N/A
N/A	Any Obstructions?	N/A	N/A	Storm Grate/Utility Hazard?	N/A
	Obstruction Type			Storm Grate/Utility Type	
		N/A			N/A
		Yes		Surface Condition? (G/P)	Good

Remove & Replace Entire Ramp.
