Intersection ID: 4428	Main Street: LONG_CREEK_PARK_DR	Cross Street: STATESVILLE_RD	Location:	NW
ADA ID: 8541B88CD3A2	Ramp Type: BlendTrans1	Initial Pass/Fail: Fail	Overall Compliance: No	Severity Score: 0

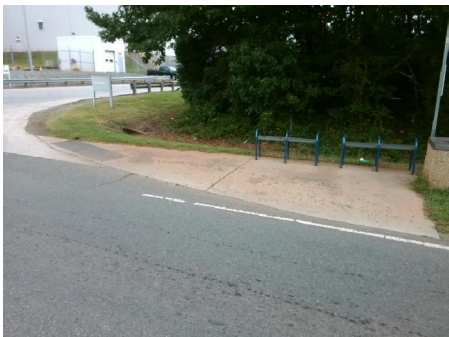
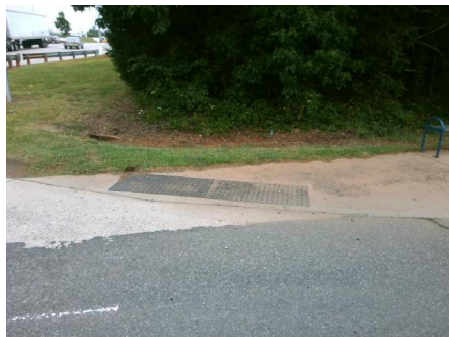
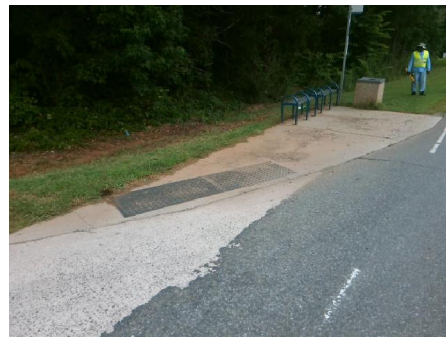
**NO CURB**

Compliance	Description	Data	Compliance	Description	Data
N/A	Ramp Length (in)	30.0	Yes	BlendTrans Slope (%)	2.7
Yes	Ramp Width (in)	96.0	Yes	BlendTrans XSlope (%)	0.4
N/A	Flare Type LT	N/A	N/A	Flare Type RT	N/A
N/A	Flare Slope LT (%)	N/A	N/A	Flare Slope RT (%)	N/A
N/A	Flare Traversable LT?	N/A	N/A	Flare Traversable RT?	N/A
N/A	Landing Length (in)	N/A	N/A	DWS Provided?	N/A
N/A	Landing Width (in)	N/A	N/A	DWS Contrast?	N/A
N/A	Landing Slope (%)	N/A	N/A	DWS Length (in)	N/A
N/A	Landing X Slope (%)	N/A	N/A	DWS Full Width?	N/A
N/A	Landing Curb? (Y/N)	N/A	N/A	DWS Offset (in)	N/A
N/A	Shared Landing?	N/A			
N/A	Gutter Ponding?	N/A	N/A	Gutter Slope (%)	N/A
N/A	Gutter Lip Ht (in)	N/A	N/A	Gutter X Slope (%)	N/A
N/A	Painted X Walk1?	No	N/A	Painted X Walk2?	N/A
	X Walk 1 Direction	To S		X Walk 2 Direction	N/A
	X Walk 1 Width (in)	N/A		X Walk 2 Width (in)	N/A
	X Walk 1 Slope (%)	4.7		X Walk 2 Slope (%)	N/A
	X Walk 1 X Slope (%)	0.5		X Walk 2 X Slope (%)	N/A

N/A	Ramp inside XWalk1?	N/A	N/A	Ramp inside XWalk2?	N/A
	Road Slope (%)	0.5		Clear Space?	N/A
	Road X Slope (%)	4.7	N/A	Clear Space to XWalk (in)	N/A
N/A	Any Obstructions?	N/A	N/A	Storm Grate/Utility Hazard?	N/A
	Obstruction Type			Storm Grate/Utility Type	
		N/A			N/A
			Yes	Surface Condition? (G/P)	Good
			N/A	Curb Slope (%)	N/A

**Remove & Replace Curb Ramp With Two New Directional Ramps or Equivalent.**

Total Cost: \$ 3200.00
