# Access Compliance Report

## Public Rights-of-Way

### (Curb Ramps)

Intersection ID: 18423	Main Street: ELESSAR_PL	Cross Street: STRIDER_DR	Location: W
ADA ID: 85498CB87DB5	Ramp Type: PerpDiag	Initial Pass/Fail: Fail	Overall Compliance: No
		Severity Score: 10

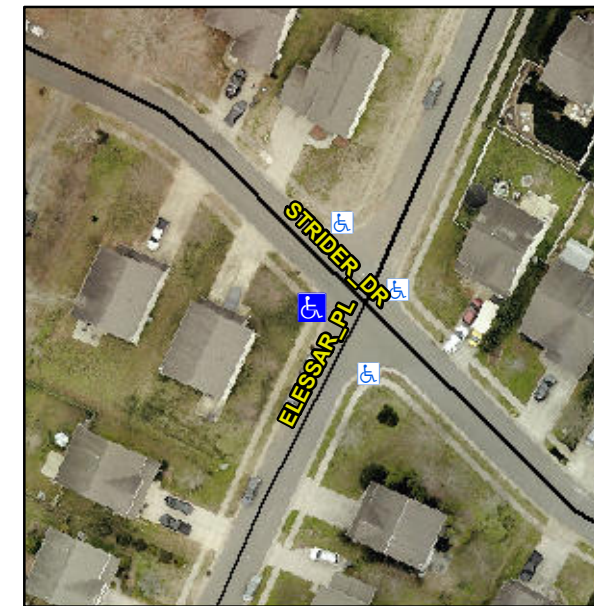
**R304.5.1, R304.5.3**

Compliance	Description	Data	Compliance	Description	Data
N/A	Ramp Length (in)	47.5	Yes	Ramp Slope (%)	7.7
No	Ramp Width (in)	46.0	No	Ramp XSlope (%)	3.1
N/A	Flare Type LT	N/A	N/A	Flare Type RT	N/A
N/A	Flare Slope LT (%)	N/A	N/A	Flare Slope RT (%)	N/A
N/A	Flare Traversable LT?	N/A	N/A	Flare Traversable RT?	N/A
N/A	Landing Length (in)	N/A	N/A	DWS Provided?	N/A
N/A	Landing Width (in)	N/A	N/A	DWS Contrast?	N/A
N/A	Landing Slope (%)	N/A	N/A	DWS Length (in)	N/A
N/A	Landing X Slope (%)	N/A	N/A	DWS Full Width?	N/A
N/A	Landing Curb? (Y/N)	N/A	N/A	DWS Offset (in)	N/A
N/A	Shared Landing?	N/A			
N/A	Gutter Ponding?	N/A	N/A	Gutter Slope (%)	N/A
N/A	Gutter Lip Ht (in)	N/A	N/A	Gutter X Slope (%)	N/A
N/A	Painted X Walk1?	No	N/A	Painted X Walk2?	No
	X Walk 1 Direction	To SE		X Walk 2 Direction	To NE
N/A	X Walk 1 Width (in)	N/A	N/A	X Walk 2 Width (in)	N/A
	X Walk 1 Slope (%)	2.6		X Walk 2 Slope (%)	1.6
	X Walk 1 X Slope (%)	0.0		X Walk 2 X Slope (%)	2.5

N/A	Ramp inside XWalk1?	N/A	N/A	Ramp inside XWalk2?	N/A
	Road Slope (%)	3.2	N/A	Clear Space?	N/A
	Road X Slope (%)	3.0	N/A	Clear Space to XWalk (in)	N/A
N/A	Any Obstructions?	N/A	N/A	Storm Grate/Utility Hazard?	N/A
	Obstruction Type			Storm Grate/Utility Type	
		N/A			N/A
			Yes	Surface Condition? (G/P)	Good

**Remove & Replace Curb Ramp With Two New Directional Ramps or Equivalent.**
