Access Compliance Report

Public Rights-of-Way

(Curb Ramps)

Intersection ID: 1003388	Main Street: WOODLAND_HILLS_RD	Cross Street: N/A	Location: SE
ADA ID: 855F5E6A9EAC	Ramp Type: Perp	Initial Pass/Fail: Fail	Overall Compliance: No
Severity Score: 13.75			
Codes/Mitigation Info/Possible Solution		Field Measurements/Component Compliance

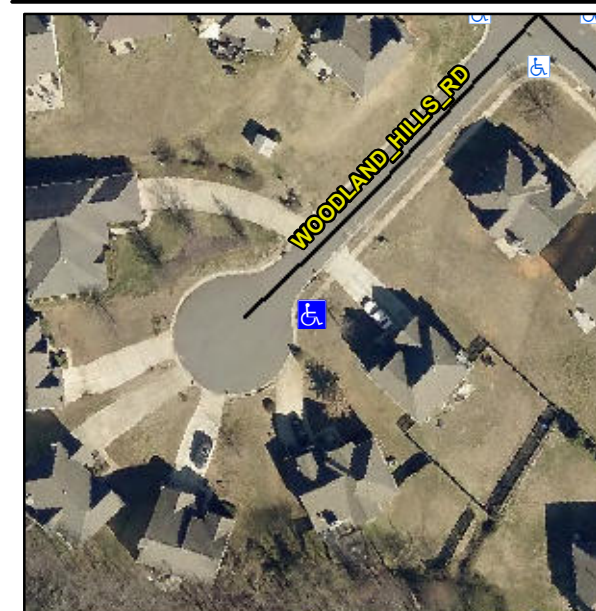
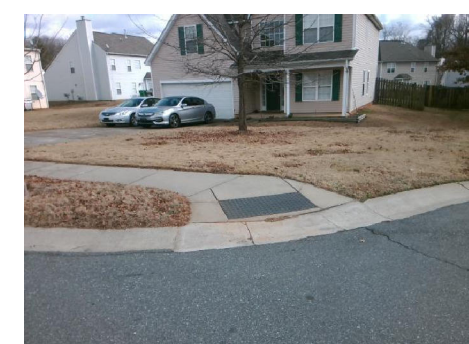
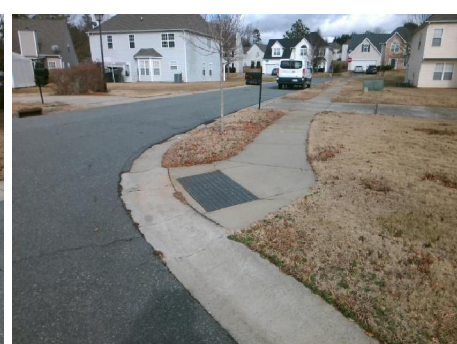
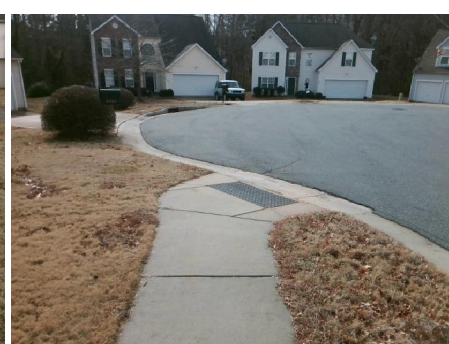
Not Found, R304.2.2

Compliance	Description	Data	Compliance	Description	Data
N/A	Ramp Length (in)	48.0	No	Ramp Slope (%)	9.1
Yes	Ramp Width (in)	48.0	Yes	Ramp XSlope (%)	2.5
N/A	Flare Type LT	N/A	N/A	Flare Type RT	N/A
N/A	Flare Slope LT (%)	N/A	N/A	Flare Slope RT (%)	N/A
N/A	Flare Traversable LT?	N/A	N/A	Flare Traversable RT?	N/A
N/A	Landing Length (in)	N/A	N/A	DWS Provided?	N/A
N/A	Landing Width (in)	N/A	N/A	DWS Contrast?	N/A
N/A	Landing Slope (%)	N/A	N/A	DWS Length (in)	N/A
N/A	Landing X Slope (%)	N/A	N/A	DWS Full Width?	N/A
N/A	Landing Curb? (Y/N)	N/A	N/A	DWS Offset (in)	N/A
N/A	Shared Landing?	N/A			
N/A	Gutter Ponding?	N/A	N/A	Gutter Slope (%)	N/A
N/A	Gutter Lip Ht (in)	N/A	N/A	Gutter X Slope (%)	N/A
N/A	Painted X Walk1?	No	N/A	Painted X Walk2?	N/A
	X Walk 1 Direction	To NW		X Walk 2 Direction	N/A
N/A	X Walk 1 Width (in)	N/A	N/A	X Walk 2 Width (in)	N/A
	X Walk 1 Slope (%)	2.1		X Walk 2 Slope (%)	N/A
	X Walk 1 X Slope (%)	3.2		X Walk 2 X Slope (%)	N/A

N/A	Ramp inside XWalk1?	N/A	N/A	Ramp inside XWalk2?	N/A
	Road Slope (%)	N/A	N/A	Clear Space?	N/A
	Road X Slope (%)	N/A	N/A	Clear Space to XWalk (in)	N/A
N/A	Any Obstructions?	N/A	N/A	Storm Grate/Utility Hazard?	N/A
	Obstruction Type			Storm Grate/Utility Type	
		N/A			N/A
			Yes	Surface Condition? (G/P)	Good

Remove & Replace Entire Ramp.
