Access Compliance Report

Public Rights-of-Way

(Curb Ramps)

Intersection ID: 5738	Main Street: HIPP_RD	Cross Street: PLEASANT_GROVE_RD	Location: W
ADA ID: 856D9E12B064	Ramp Type: Perp	Initial Pass/Fail: Fail	Overall Compliance: No
Severity Score: 10			
Codes/Mitigation Info/Possible Solution		Field Measurements/Component Compliance

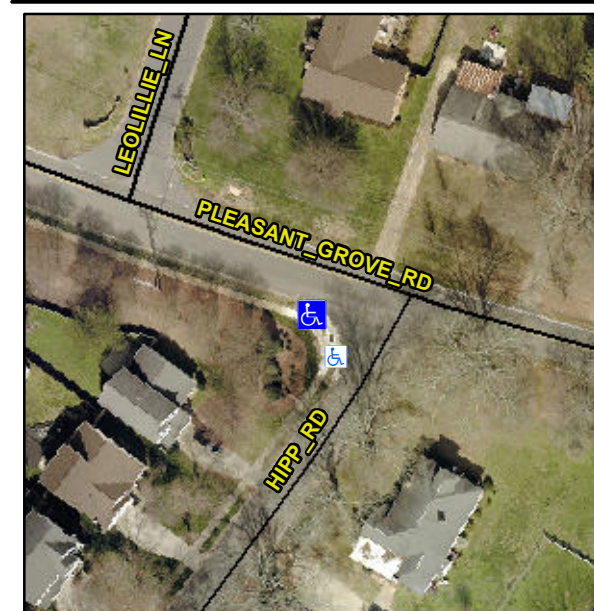
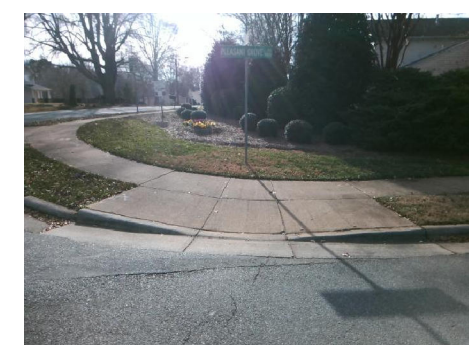
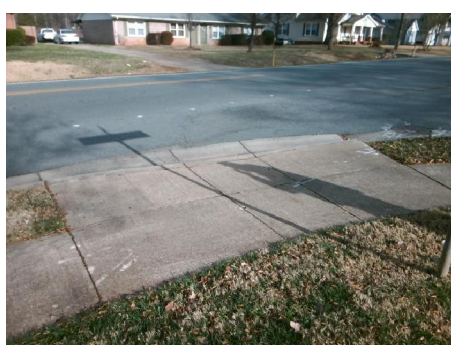
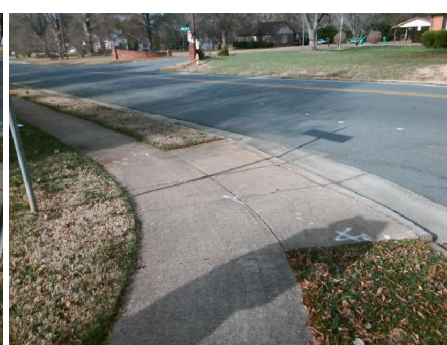
Not Found, R304.5.1, R304.5.3

Compliance	Description	Data	Compliance	Description	Data
N/A	Ramp Length (in)	48.0	Yes	Ramp Slope (%)	6.8
No	Ramp Width (in)	37.5	No	Ramp XSlope (%)	3.8
N/A	Flare Type LT	N/A	N/A	Flare Type RT	N/A
N/A	Flare Slope LT (%)	N/A	N/A	Flare Slope RT (%)	N/A
N/A	Flare Traversable LT?	N/A	N/A	Flare Traversable RT?	N/A
N/A	Landing Length (in)	N/A	N/A	DWS Provided?	N/A
N/A	Landing Width (in)	N/A	N/A	DWS Contrast?	N/A
N/A	Landing Slope (%)	N/A	N/A	DWS Length (in)	N/A
N/A	Landing X Slope (%)	N/A	N/A	DWS Full Width?	N/A
N/A	Landing Curb? (Y/N)	N/A	N/A	DWS Offset (in)	N/A
N/A	Shared Landing?	N/A			
N/A	Gutter Ponding?	N/A	N/A	Gutter Slope (%)	N/A
N/A	Gutter Lip Ht (in)	N/A	N/A	Gutter X Slope (%)	N/A
N/A	Painted X Walk1?	No	N/A	Painted X Walk2?	N/A
	X Walk 1 Direction	To N		X Walk 2 Direction	N/A
N/A	X Walk 1 Width (in)	N/A	N/A	X Walk 2 Width (in)	N/A
	X Walk 1 Slope (%)	3.4		X Walk 2 Slope (%)	N/A
	X Walk 1 X Slope (%)	2.9		X Walk 2 X Slope (%)	N/A

N/A	Ramp inside XWalk1?	N/A	N/A	Ramp inside XWalk2?	N/A
	Road Slope (%)	2.9	N/A	Clear Space?	N/A
	Road X Slope (%)	3.4	N/A	Clear Space to XWalk (in)	N/A
N/A	Any Obstructions?	N/A	N/A	Storm Grate/Utility Hazard?	N/A
	Obstruction Type			Storm Grate/Utility Type	
		N/A			N/A
			Yes	Surface Condition? (G/P)	Good

Possible Solutions:

Remove & Replace Entire Ramp.
