# Access Compliance Report

## Public Rights-of-Way

### (Curb Ramps)

Intersection ID: 27363	Main Street: REA_RD	Cross Street: BALLANTYNE_COMMONS_PY	Location: SE
ADA ID: 85718400A38A	Ramp Type: ParaDiag	Initial Pass/Fail: Fail	Overall Compliance: No
Severity Score: 37.5			
Codes/Mitigation Info/Possible Solution		Field Measurements/Component Compliance

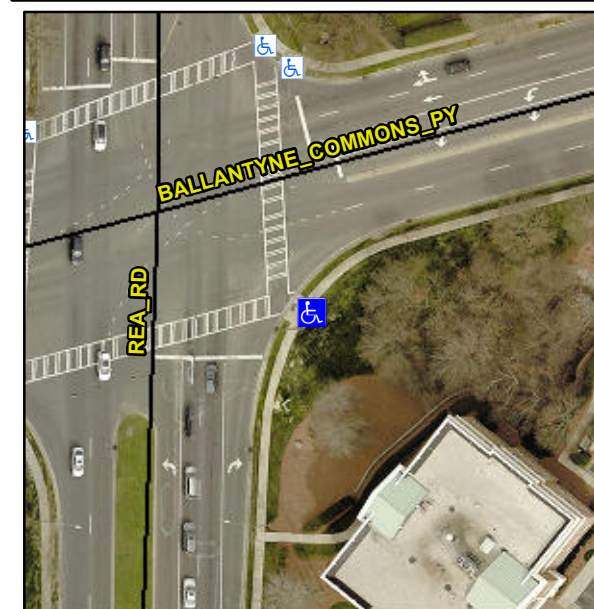
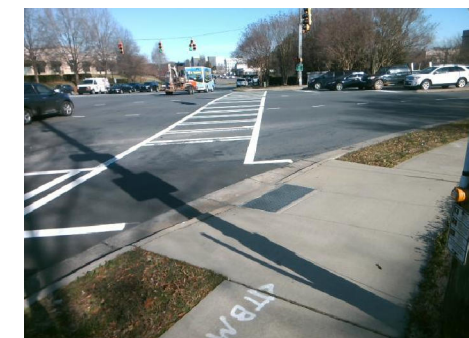
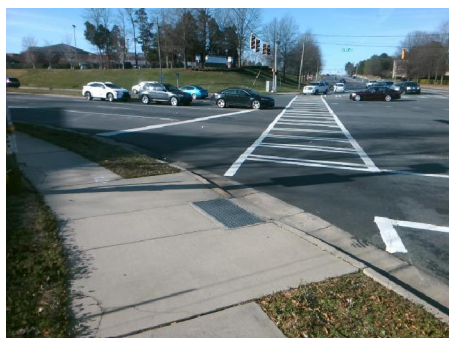
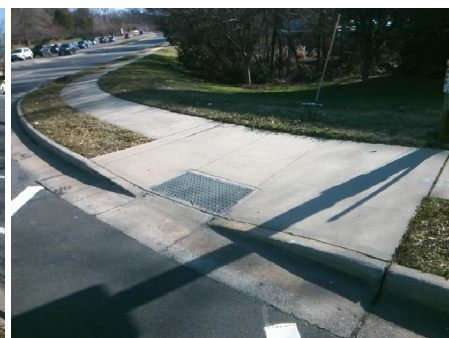
Compliance	Description	Data	Compliance	Description	Data
N/A	Ramp Length LT (in)	66.0	N/A	Ramp Length RT (in)	68.0
Yes	Ramp Width LT (in)	107.0	Yes	Ramp Width RT (in)	106.0
No	Ramp Slope LT (%)	8.6	No	Ramp Slope RT (%)	8.4
No	Ramp XSlope LT (%)	7.3	Yes	Ramp XSlope RT (%)	2.0
N/A	Landing Length (in)	N/A	N/A	DWS Provided?	N/A
N/A	Landing Width (in)	N/A	N/A	DWS Contrast?	N/A
N/A	Landing Slope (%)	N/A	N/A	DWS Length (in)	N/A
N/A	Landing X Slope (%)	N/A	N/A	DWS Full Width?	N/A
N/A	Landing Curb? (Y/N)	N/A	N/A	DWS Offset (in)	N/A
N/A	Shared Landing?	N/A			
N/A	Gutter Ponding?	N/A	N/A	Gutter Slope (%)	N/A
N/A	Gutter Lip Ht (in)	N/A	N/A	Gutter X Slope (%)	N/A
N/A	Painted X Walk1?	Yes	N/A	Painted X Walk2?	Yes
	X Walk 1 Direction	To N		X Walk 2 Direction	To W
N/A	X Walk 1 Width (in)	120.0	N/A	X Walk 2 Width (in)	119.0
	X Walk 1 Slope (%)	2.1		X Walk 2 Slope (%)	2.5
	X Walk 1 X Slope (%)	1.1		X Walk 2 X Slope (%)	0.6
N/A	Ramp inside XWalk1?	Yes	N/A	Ramp inside XWalk2?	Yes

Road Slope (%)	0.8	N/A	Clear Space?	N/A
	Road X Slope (%)	3.0	N/A	Clear Space to XWalk (in)	N/A
N/A	Any Obstructions?	N/A	N/A	Storm Grate/Utility Hazard?	N/A
	Obstruction Type			Storm Grate/Utility Type	
		N/A			N/A
			Yes	Surface Condition? (G/P)	Good
			N/A	Curb Slope (%)	10.8

**Remove & Replace Curb Ramp With Two New Directional Ramps or Equivalent.**

Total Cost: \$ 3200.00
