## **Access Compliance Report Public Rights-of-Way** (Curb Ramps)

Intersection ID: 47017 Main Street: MOORES\_CHAPEL\_RD Cross Street: KRAUS\_GLEN\_DR Location: NW **Overall Compliance: No** ADA ID: 857199E7FB3C Ramp Type: Perp Initial Pass/Fail: Fail Severity Score: 21.25

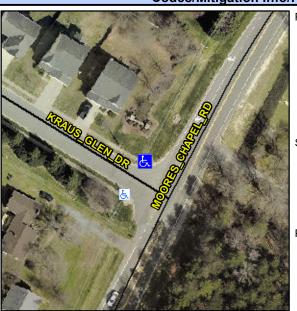
**KRAUS GLEN DR** Street 1 Name Stop Condition-Street 2 StopSign Street 2 Name N/A Stop Condition-Street 1 N/A

Possible Solutions:	9
Remove & Replace Entire Ramp.	ı
•	1
	N
	1
	N
	ı
Surveyor Notes:	N
N/A	ı
	N
	N
	N
PROW/ADA:	N
Not Found, R304.5.1, R304.5.3	N
,	1
	1
	N

Field Measurements/Component Compliance							
Compl	iance Description	Data	Compl	iance Description	Data		
N/A	Ramp Length (in)	98.0	Yes	Ramp Slope (%)	5.0		
No	Ramp Width (in)	45.5	No	Ramp XSlope (%)	5.9		
N/A	Flare Type LT	N/A	N/A	Flare Type RT	N/A		
N/A	Flare Slope LT (%)	N/A	N/A	Flare Slope RT (%)	N/A		
N/A	Flare Traversable LT?	N/A	N/A	Flare Traversable RT?	N/A		
N/A	Landing Length (in)	N/A	N/A	DWS Provided?	N/A		
N/A	Landing Width (in)	N/A	N/A	DWS Contrast?	N/A		
N/A	Landing Slope (%)	N/A	N/A	DWS Length (in)	N/A		
N/A	Landing X Slope (%)	N/A	N/A	DWS Full Width?	N/A		
N/A	Landing Curb? (Y/N)	N/A	N/A	DWS Offset (in)	N/A		
N/A	Shared Landing?	N/A					
N/A	Gutter Ponding?	N/A	N/A	Gutter Slope (%)	N/A		
N/A	Gutter Lip Ht (in)	N/A	N/A	Gutter X Slope (%)	N/A		
N/A	Painted X Walk1?	No	N/A	Painted X Walk2?	N/A		
	X Walk 1 Direction	To SW		X Walk 2 Direction	N/A		
N/A	X Walk 1 Width (in)	N/A	N/A	X Walk 2 Width (in)	N/A

X Walk 1 Slope (%)	0.1		X Walk 2 Slope (%)	N/A		
	X Walk 1 X Slope (%)	2.9		X Walk 2 X Slope (%)	N/A		
N/A	Ramp inside XWalk1?	N/A	N/A	Ramp inside XWalk2?	N/A		
	Road Slope (%)	N/A	N/A	Clear Space?	N/A		
	Road X Slope (%)	N/A	N/A	Clear Space to XWalk (in)	N/A		
N/A	Any Obstructions?	N/A	N/A	Storm Grate/Utility Hazard?	N/A		
	Obstruction Type			Storm Grate/Utility Type			
		N/A			N/A		
			Yes	Surface Condition? (G/P)	Good

1850.00
