# Access Compliance Report

## Public Rights-of-Way

### (Curb Ramps)

| Intersection ID: 27531 | Main Street: BALLANTYNE COMMONS PY | Cross Street: PLANTATION PARK BV | Location: SW |

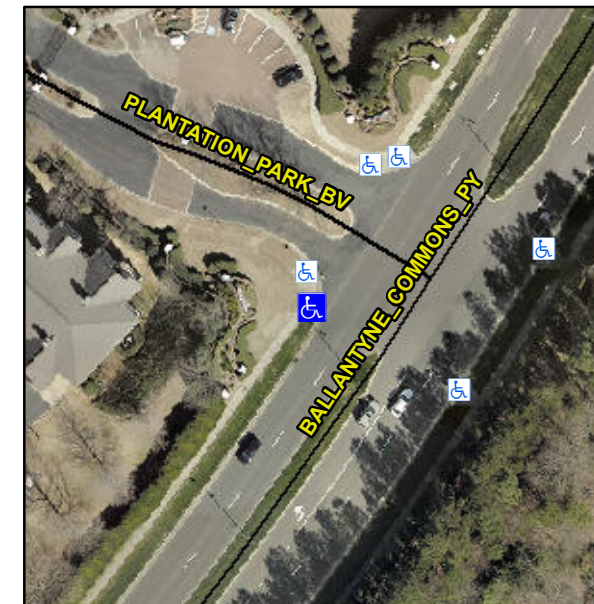
| ADA ID: 8583B7B99934 | Ramp Type: Perp | Initial Pass/Fail: Fail | Overall Compliance: No |
| Severity Score: 33.75 | | | |

**Not Found, R304.5.1, R304.2.2, R304.5.3**

| Compliance | Description | Data | Compliance | Description | Data |
|---|---|---|---|---|---|
| N/A | Ramp Length (in) | 115.0 | No | Ramp Slope (%) | 8.5 |
| No | Ramp Width (in) | 37.0 | No | Ramp XSlope (%) | 5.6 |

**Remove & Replace Entire Ramp.**

Total Cost: \$ 1850.00
