Access Compliance Report

Public Rights-of-Way

(Curb Ramps)

Intersection ID: 11847	Main Street: N_TRYON_ST	Cross Street: W_9TH_ST	Location:	N
ADA ID: 858E28A36D23	Ramp Type: PerpDiag	Initial Pass/Fail: Fail	Overall Compliance: No	Severity Score: 10

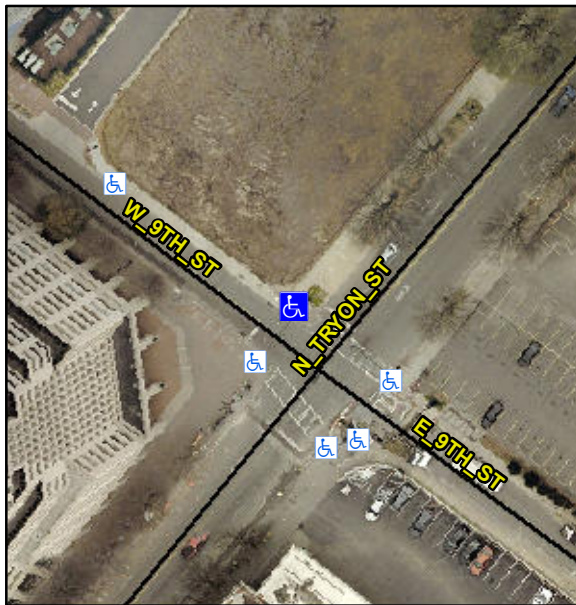
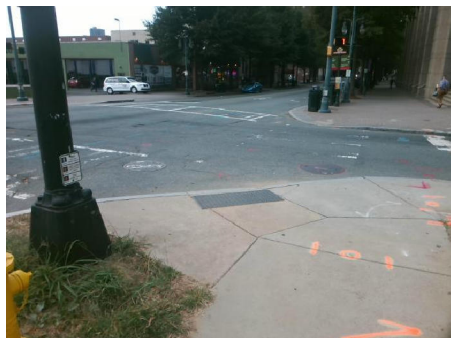
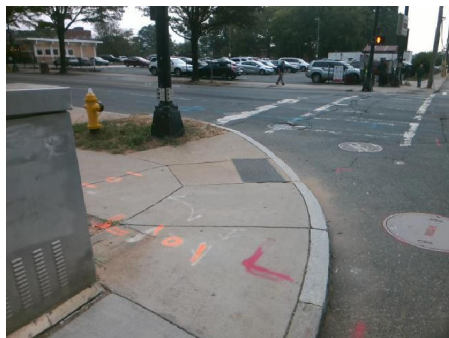
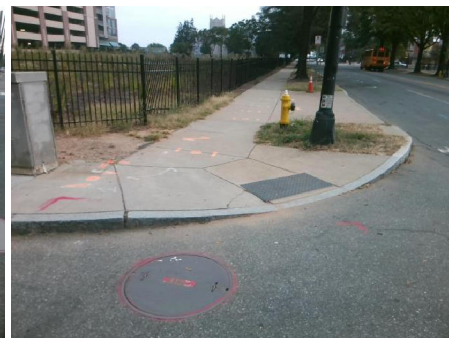
Not Found, R304.5.1, R304.5.3

Compliance	Description	Data	Compliance	Description	Data
N/A	Ramp Length (in)	61.0	Yes	Ramp Slope (%)	6.0
No	Ramp Width (in)	41.5	No	Ramp XSlope (%)	3.2
N/A	Flare Type LT	N/A	N/A	Flare Type RT	N/A
N/A	Flare Slope LT (%)	N/A	N/A	Flare Slope RT (%)	N/A
N/A	Flare Traversable LT?	N/A	N/A	Flare Traversable RT?	N/A
N/A	Landing Length (in)	N/A	N/A	DWS Provided?	N/A
N/A	Landing Width (in)	N/A	N/A	DWS Contrast?	N/A
N/A	Landing Slope (%)	N/A	N/A	DWS Length (in)	N/A
N/A	Landing X Slope (%)	N/A	N/A	DWS Full Width?	N/A
N/A	Landing Curb? (Y/N)	N/A	N/A	DWS Offset (in)	N/A
N/A	Shared Landing?	N/A			
N/A	Gutter Ponding?	N/A	N/A	Gutter Slope (%)	N/A
N/A	Gutter Lip Ht (in)	N/A	N/A	Gutter X Slope (%)	N/A
N/A	Painted X Walk1?	Yes	N/A	Painted X Walk2?	Yes
	X Walk 1 Direction	To SW		X Walk 2 Direction	To SE
N/A	X Walk 1 Width (in)	112.0	N/A	X Walk 2 Width (in)	104.0
	X Walk 1 Slope (%)	1.2		X Walk 2 Slope (%)	1.6
	X Walk 1 X Slope (%)	1.7		X Walk 2 X Slope (%)	1.3

N/A	Ramp inside XWalk1?	Yes	N/A	Ramp inside XWalk2?	Yes
	Road Slope (%)	0.3	N/A	Clear Space?	N/A
	Road X Slope (%)	1.6	N/A	Clear Space to XWalk (in)	N/A
N/A	Any Obstructions?	N/A	N/A	Storm Grate/Utility Hazard?	N/A
	Obstruction Type			Storm Grate/Utility Type	
		N/A			N/A
		Yes		Surface Condition? (G/P)	Good

Remove & Replace Curb Ramp With Two New Directional Ramps or Equivalent.
