# Access Compliance Report

## Public Rights-of-Way

### (Curb Ramps)

Intersection ID: 10023649	Main Street: CLOVERLEAF_CT	Cross Street: N/A	Location: SE
ADA ID: 85980720E066	Ramp Type: Perp	Initial Pass/Fail: Pass	Overall Compliance: No
Codes/Mitigation Info/Possible Solution		Field Measurements/Component Compliance	
Severity Score: 10

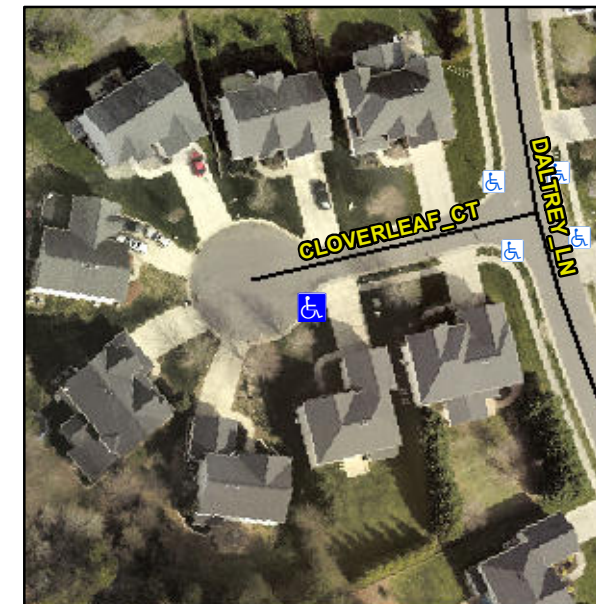
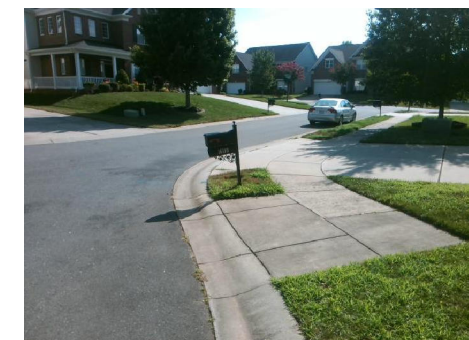
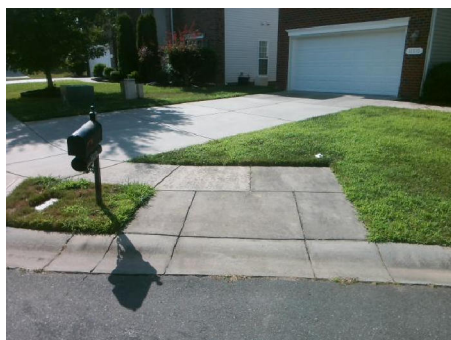
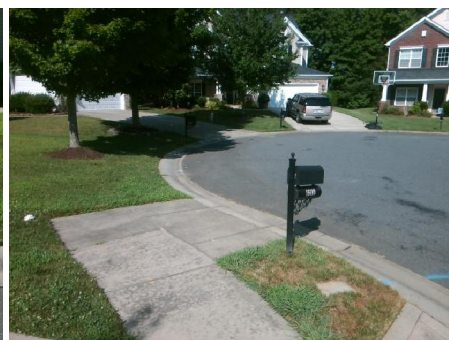
**Not Found, R305**

Compliance	Description	Data	Compliance	Description	Data
N/A	Ramp Length (in)	48.0	Yes	Ramp Slope (%)	7.0
Yes	Ramp Width (in)	51.0	Yes	Ramp XSlope (%)	1.2
N/A	Flare Type LT	Sloped	N/A	Flare Type RT	N/A
N/A	Flare Slope LT (%)	5.6	N/A	Flare Slope RT (%)	2.5
N/A	Flare Traversable LT?	Yes	N/A	Flare Traversable RT?	No
Yes	Landing Length (in)	48.0	No	DWS Provided?	No
Yes	Landing Width (in)	51.0	N/A	DWS Contrast?	No
Yes	Landing Slope (%)	1.7	N/A	DWS Length (in)	N/A
Yes	Landing X Slope (%)	0.3	N/A	DWS Full Width?	No
N/A	Landing Curb? (Y/N)	No	N/A	DWS Offset (in)	N/A
N/A	Shared Landing?	No			
Yes	Gutter Ponding?	No	Yes	Gutter Slope (%)	0.9
Yes	Gutter Lip Ht (in)	0.0	Yes	Gutter X Slope (%)	1.9
N/A	Painted X Walk1?	No	N/A	Painted X Walk2?	N/A
	X Walk 1 Direction	To N		X Walk 2 Direction	N/A
N/A	X Walk 1 Width (in)	N/A	N/A	X Walk 2 Width (in)	N/A
	X Walk 1 Slope (%)	1.2		X Walk 2 Slope (%)	N/A
	X Walk 1 X Slope (%)	0.4		X Walk 2 X Slope (%)	N/A

N/A	Ramp inside XWalk1?	N/A	N/A	Ramp inside XWalk2?	N/A
	Road Slope (%)	N/A	N/A	Clear Space?	Yes
	Road X Slope (%)	N/A	N/A	Clear Space to XWalk (in)	N/A
Yes	Any Obstructions?	No	Yes	Storm Grate/Utility Hazard?	No
	Obstruction Type			Storm Grate/Utility Type	
		N/A			N/A
			Yes	Surface Condition? (G/P)	Good

**Remove & Replace Entire Ramp.**

Total Cost: \$ 1850.00
