# Access Compliance Report

## Public Rights-of-Way (Curb Ramps)

| Intersection ID: 49359 | Main Street: PARK_SOUTH_DR | Cross Street: GARDEN_PATH_LN | Location: E |
| ADA ID: 859A6056CF8B | Ramp Type: PerpDiag | Initial Pass/Fail: Fail | Overall Compliance: No |

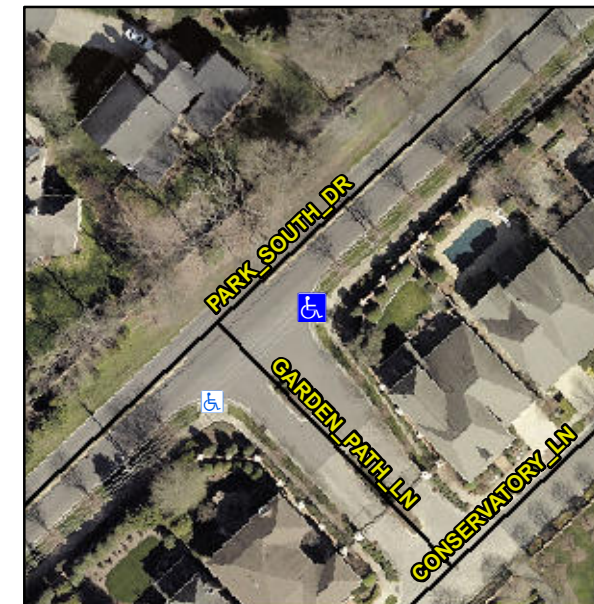
| | | Severity Score: 25 | |

**Not Found, R304.5.3**

| Compliance | Description | Data | Compliance | Description | Data |
|---|---|---|---|---|---|
| N/A | Ramp Length (in) | 132.0 | Yes | Ramp Slope (%) | 7.1 |
| Yes | Ramp Width (in) | 48.0 | No | Ramp XSlope (%) | 11.2 |

**Remove & Replace Curb Ramp With Two New Directional Ramps or Equivalent.**

Total Cost: \$ 3200.00
