Access Compliance Report

Public Rights-of-Way

(Curb Ramps)

Intersection ID: 28292	Main Street: ARVIND_OAKS_CT	Cross Street: KRISHNA_LN	Location: SE
ADA ID: 85A5B2FA5F8B	Ramp Type: PerpDiag	Initial Pass/Fail: Fail	Overall Compliance: No
Severity Score: 21.25			
Codes/Mitigation Info/Possible Solution		Field Measurements/Component Compliance

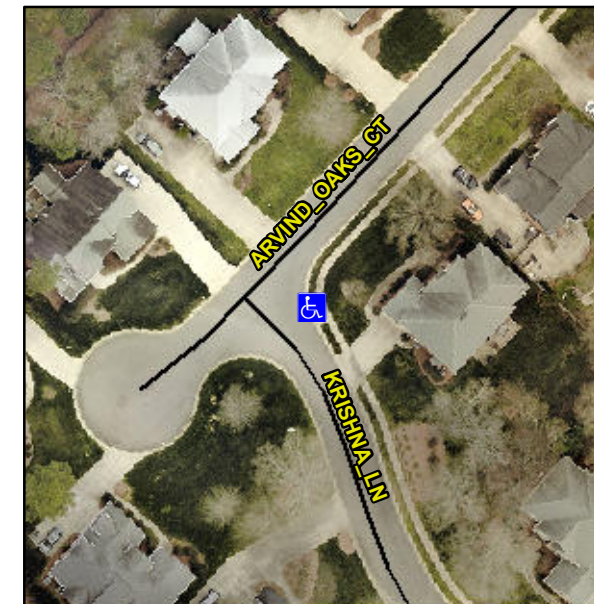
Compliance	Description	Data	Compliance	Description	Data
N/A	Ramp Length (in)	47.0	No	Ramp Slope (%)	10.4
No	Ramp Width (in)	42.0	Yes	Ramp XSlope (%)	0.5
N/A	Flare Type LT	N/A	N/A	Flare Type RT	N/A
N/A	Flare Slope LT (%)	N/A	N/A	Flare Slope RT (%)	N/A
N/A	Flare Traversable LT?	N/A	N/A	Flare Traversable RT?	N/A
N/A	Landing Length (in)	N/A	N/A	DWS Provided?	N/A
N/A	Landing Width (in)	N/A	N/A	DWS Contrast?	N/A
N/A	Landing Slope (%)	N/A	N/A	DWS Length (in)	N/A
N/A	Landing X Slope (%)	N/A	N/A	DWS Full Width?	N/A
N/A	Landing Curb? (Y/N)	N/A	N/A	DWS Offset (in)	N/A
N/A	Shared Landing?	N/A			
N/A	Gutter Ponding?	N/A	N/A	Gutter Slope (%)	N/A
N/A	Gutter Lip Ht (in)	N/A	N/A	Gutter X Slope (%)	N/A
N/A	Painted X Walk1?	No	N/A	Painted X Walk2?	No
	X Walk 1 Direction	To NW		X Walk 2 Direction	To SW
N/A	X Walk 1 Width (in)	N/A	N/A	X Walk 2 Width (in)	N/A
	X Walk 1 Slope (%)	1.8		X Walk 2 Slope (%)	3.4
	X Walk 1 X Slope (%)	4.2		X Walk 2 X Slope (%)	2.1

N/A	Ramp inside XWalk1?	N/A	N/A	Ramp inside XWalk2?	N/A
	Road Slope (%)	0.1	N/A	Clear Space?	N/A
	Road X Slope (%)	4.1	N/A	Clear Space to XWalk (in)	N/A
N/A	Any Obstructions?	N/A	N/A	Storm Grate/Utility Hazard?	N/A
	Obstruction Type			Storm Grate/Utility Type	
		N/A			N/A
			Yes	Surface Condition? (G/P)	Good

Possible Solutions:

Remove & Replace Curb Ramp With Two New Directional Ramps or Equivalent.
