# Access Compliance Report

## Public Rights-of-Way

### (Curb Ramps)

| Intersection ID: N/A | Main Street: SUMMERFIELD RIDGE LN | Cross Street: CROSS POINT CIR | Location: SW |

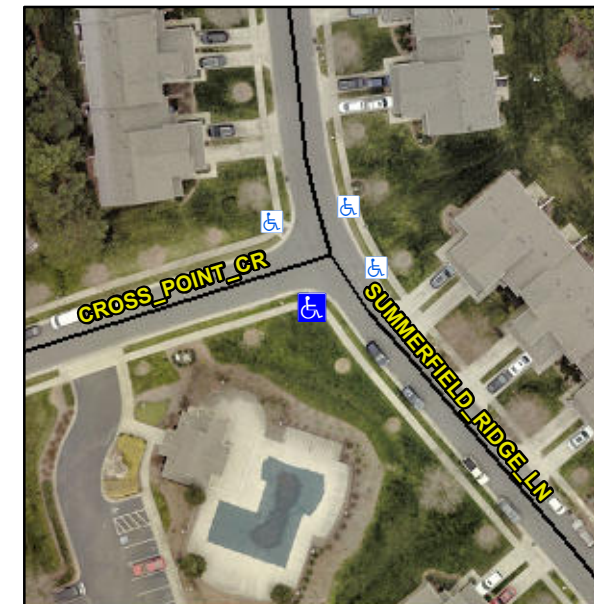
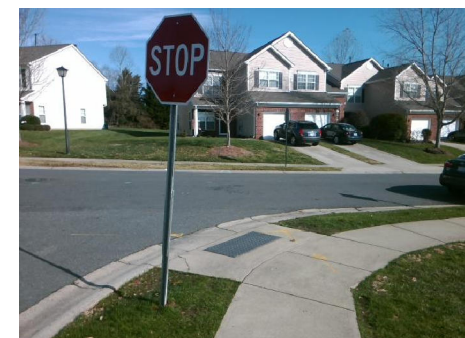
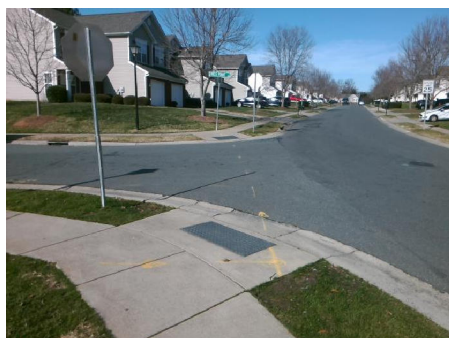
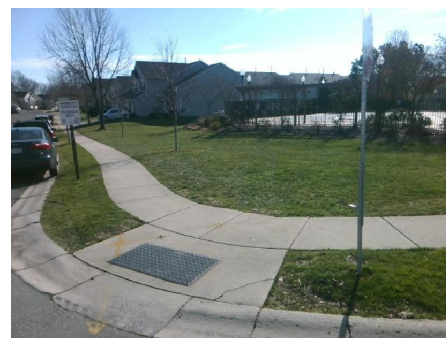
| ADA ID: 85A79D846F9C | Ramp Type: BlendTrans1 | Initial Pass/Fail: Fail | Overall Compliance: No |

**R304.5.3**

| Compliance | Description | Data | Compliance | Description | Data |
|---|---|---|---|---|---|
| Yes | Ramp Width (in) | 48.0 | No | BlendTrans XSlope (%) | 3.2 |

**Remove & Replace Curb Ramp With Two New Directional Ramps or Equivalent.**

**\$ 3200.00**
