Access Compliance Report

Public Rights-of-Way

(Curb Ramps)

Intersection ID: 49315	Main Street: ANNA_JORDAN_DR	Cross Street: ROCKLAND_DR	Location: NW
ADA ID: 85B7BB697714	Ramp Type: PerpDiag	Initial Pass/Fail: Fail	Overall Compliance: No
		Severity Score: 8.75

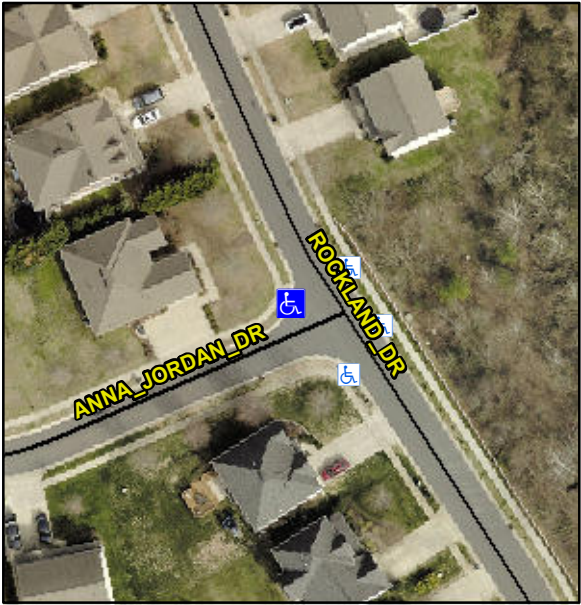
Possible Solutions:		Compliance	Description	Data
	Remove & Replace Curb Ramp With Two New Directional Ramps or Equivalent.		Yes	Ramp Length (in)	6.0
			No	Ramp Width (in)	0.7
			N/A	Flare Type LT	N/A
			N/A	Flare Slope LT (%)	N/A
			N/A	Flare Traversable LT?	N/A
			N/A	Landing Length (in)	N/A
			N/A	Landing Width (in)	N/A
			N/A	Landing Slope (%)	N/A
			N/A	Landing X Slope (%)	N/A
<p>Surveyor Notes:</p> <p>N/A</p> <p>PROW/ADA:</p> <p>Not Found, R304.5.1</p>			N/A	Flare Type RT	N/A
			N/A	Flare Slope RT (%)	N/A
			N/A	Flare Traversable RT?	N/A
			N/A	DWS Provided?	N/A
			N/A	DWS Contrast?	N/A
			N/A	DWS Length (in)	N/A
			N/A	DWS Full Width?	N/A
			N/A	DWS Offset (in)	N/A
			N/A	Gutter Ponding?	N/A
			N/A	Gutter Lip Ht (in)	N/A
			No	Painted X Walk1?	No
				X Walk 1 Direction	To S
			N/A	X Walk 1 Width (in)	N/A

1.3	X Walk 1 Slope (%)	2.1
			0.7	X Walk 1 X Slope (%)	3.2
			N/A	Ramp inside XWalk1?	N/A
			1.4	Road Slope (%)	N/A
			0.2	Road X Slope (%)	N/A
			N/A	Any Obstructions?	N/A
				Obstruction Type	
Total Cost:		\$ 3200.00	N/A	Storm Grate/Utility Hazard?	N/A
			N/A	Storm Grate/Utility Type	N/A
			Yes	Surface Condition? (G/P)	Good
