# Access Compliance Report

## Public Rights-of-Way

### (Curb Ramps)

Intersection ID: 22250	Main Street: SHARON_LAKES_RD	Cross Street: SOUTH_BV	Location: NW
ADA ID: 85BF8C5C4FE9	Ramp Type: Perp	Initial Pass/Fail: Fail	Overall Compliance: No
		Severity Score: 35

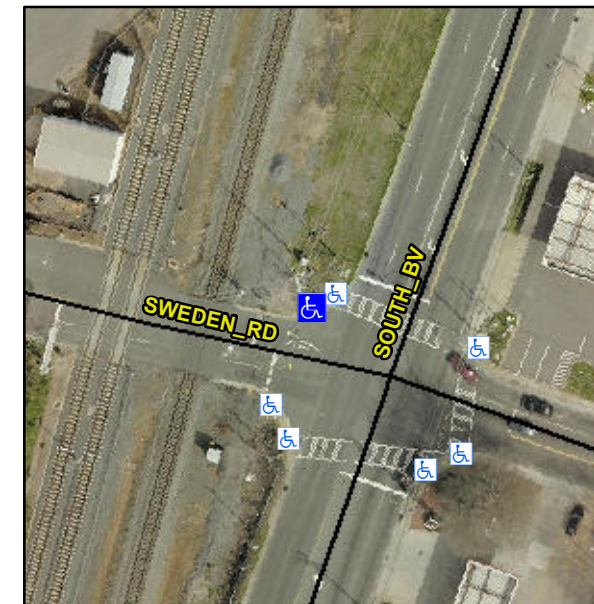
**Not Found, R304.5.1, R304.2.2**

Compliance	Description	Data	Compliance	Description	Data
N/A	Ramp Length (in)	48.0	No	Ramp Slope (%)	12.0
No	Ramp Width (in)	38.0	Yes	Ramp XSlope (%)	3.6
N/A	Flare Type LT	N/A	N/A	Flare Type RT	N/A
N/A	Flare Slope LT (%)	N/A	N/A	Flare Slope RT (%)	N/A
N/A	Flare Traversable LT?	N/A	N/A	Flare Traversable RT?	N/A
N/A	Landing Length (in)	N/A	N/A	DWS Provided?	N/A
N/A	Landing Width (in)	N/A	N/A	DWS Contrast?	N/A
N/A	Landing Slope (%)	N/A	N/A	DWS Length (in)	N/A
N/A	Landing X Slope (%)	N/A	N/A	DWS Full Width?	N/A
N/A	Landing Curb? (Y/N)	N/A	N/A	DWS Offset (in)	N/A
N/A	Shared Landing?	N/A			
N/A	Gutter Ponding?	N/A	N/A	Gutter Slope (%)	N/A
N/A	Gutter Lip Ht (in)	N/A	N/A	Gutter X Slope (%)	N/A
N/A	Painted X Walk1?	No	N/A	Painted X Walk2?	N/A
	X Walk 1 Direction	To SW		X Walk 2 Direction	N/A
N/A	X Walk 1 Width (in)	N/A	N/A	X Walk 2 Width (in)	N/A
	X Walk 1 Slope (%)	0.0		X Walk 2 Slope (%)	N/A
	X Walk 1 X Slope (%)	4.8		X Walk 2 X Slope (%)	N/A

N/A	Ramp inside XWalk1?	N/A	N/A	Ramp inside XWalk2?	N/A
	Road Slope (%)	N/A	N/A	Clear Space?	N/A
	Road X Slope (%)	N/A	N/A	Clear Space to XWalk (in)	N/A
N/A	Any Obstructions?	N/A	N/A	Storm Grate/Utility Hazard?	N/A
	Obstruction Type			Storm Grate/Utility Type	
		N/A			N/A
			Yes	Surface Condition? (G/P)	Good

**Remove & Replace Entire Ramp.**
