Access Compliance Report

Public Rights-of-Way

(Curb Ramps)

Intersection ID: 10003849	Main Street: DIXIE_RIVER_RD	Cross Street: NEW_FASHION_WY	Location: NE
ADA ID: 85BFB2E7ADA2	Ramp Type: Perp	Initial Pass/Fail: Fail	Overall Compliance: No
		Severity Score: 22.5

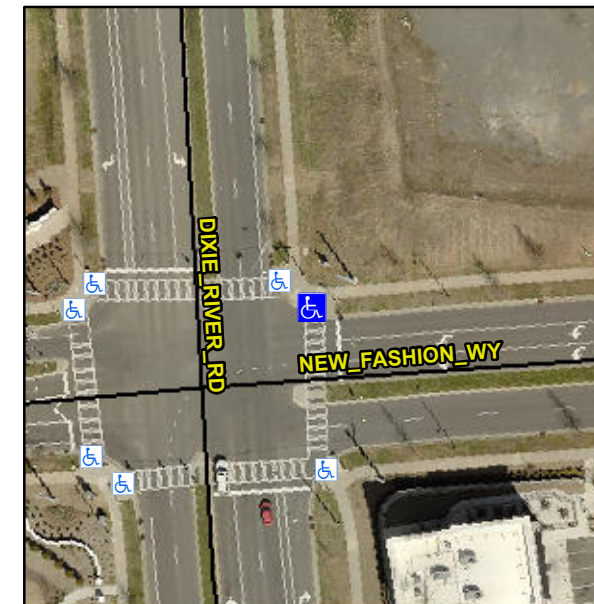
R304.5.1, R304.2.2, R304.5.3

Compliance	Description	Data	Compliance	Description	Data
N/A	Ramp Length (in)	82.0	No	Ramp Slope (%)	8.8
No	Ramp Width (in)	44.0	No	Ramp XSlope (%)	3.5
N/A	Flare Type LT	N/A	N/A	Flare Type RT	N/A
N/A	Flare Slope LT (%)	N/A	N/A	Flare Slope RT (%)	N/A
N/A	Flare Traversable LT?	N/A	N/A	Flare Traversable RT?	N/A
N/A	Landing Length (in)	N/A	N/A	DWS Provided?	N/A
N/A	Landing Width (in)	N/A	N/A	DWS Contrast?	N/A
N/A	Landing Slope (%)	N/A	N/A	DWS Length (in)	N/A
N/A	Landing X Slope (%)	N/A	N/A	DWS Full Width?	N/A
N/A	Landing Curb? (Y/N)	N/A	N/A	DWS Offset (in)	N/A
N/A	Shared Landing?	N/A			
N/A	Gutter Ponding?	N/A	N/A	Gutter Slope (%)	N/A
N/A	Gutter Lip Ht (in)	N/A	N/A	Gutter X Slope (%)	N/A
N/A	Painted X Walk1?	Yes	N/A	Painted X Walk2?	N/A
	X Walk 1 Direction	To S		X Walk 2 Direction	N/A
N/A	X Walk 1 Width (in)	111.0	N/A	X Walk 2 Width (in)	N/A
	X Walk 1 Slope (%)	2.2		X Walk 2 Slope (%)	N/A
	X Walk 1 X Slope (%)	2.5		X Walk 2 X Slope (%)	N/A

N/A	Ramp inside XWalk1?	Yes	N/A	Ramp inside XWalk2?	N/A
	Road Slope (%)	N/A	N/A	Clear Space?	N/A
	Road X Slope (%)	N/A	N/A	Clear Space to XWalk (in)	N/A
N/A	Any Obstructions?	N/A	N/A	Storm Grate/Utility Hazard?	N/A
	Obstruction Type			Storm Grate/Utility Type	
		N/A			N/A
			Yes	Surface Condition? (G/P)	Good

Remove & Replace Entire Ramp.
