# Access Compliance Report

## Public Rights-of-Way

### (Curb Ramps)

| Intersection ID: 12365 | Main Street: E_10TH_ST | Cross Street: N_ALEXANDER_ST | Location: S |

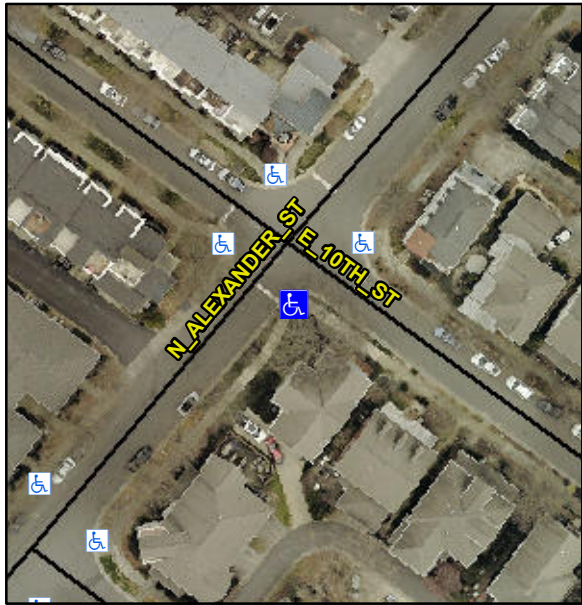
| ADA ID: 85C83C082847 | Ramp Type: PerpDiag | Initial Pass/Fail: Fail | Overall Compliance: No |

| Codes/Mitigation Info/Possible Solution | | | Field Measurements/Component Compliance | | | | | |
|---|---|---|---|---|---|---|---|---|
| | | | No | Ramp Width (in) | 39.0 | No | Ramp XSlope (%) | 9.8 |
| PROW/ADA: | | Not Found, R304.5.1, R304.5.3 | N/A | Shared Landing? | N/A | | | |

| Codes/Mitigation Info/Possible Solution | | | Field Measurements/Component Compliance | | | | | |
|---|---|---|---|---|---|---|---|---|
| | Remove & Replace Curb Ramp With Two New Directional Ramps or Equivalent. | | N/A | Ramp Length (in) | 29.0 | Yes | Ramp Slope (%) | 7.3 |
