Access Compliance Report

Public Rights-of-Way

(Curb Ramps)

Intersection ID: 50904	Main Street: KARRAS COMMONS_WY	Cross Street: TILLEY MORRIS_RD	Location: NW
ADA ID: 85CC23A6DB47	Ramp Type: Perp	Initial Pass/Fail: Fail	Overall Compliance: No
			Severity Score: 10

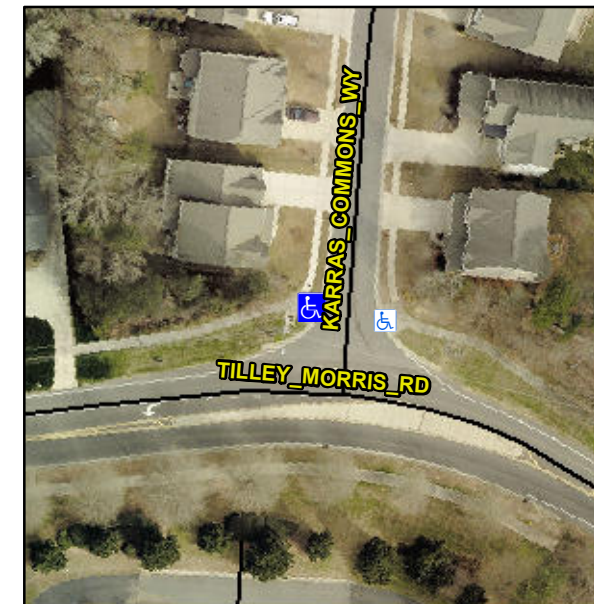
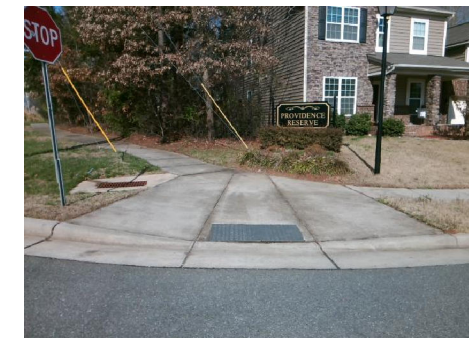
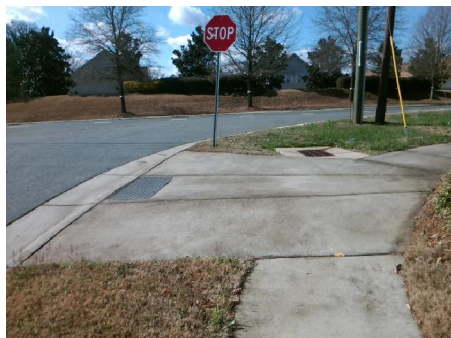
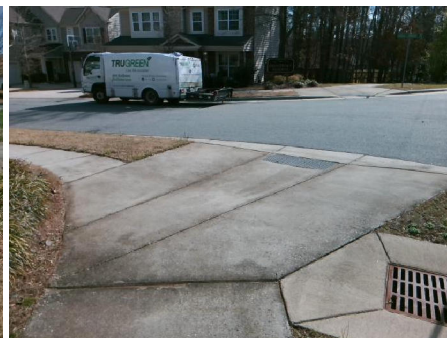
Not Found, R304.5.1, R304.5.3

Compliance	Description	Data	Compliance	Description	Data
N/A	Ramp Length (in)	88.0	Yes	Ramp Slope (%)	5.0
No	Ramp Width (in)	44.0	No	Ramp XSlope (%)	3.0
N/A	Flare Type LT	N/A	N/A	Flare Type RT	N/A
N/A	Flare Slope LT (%)	N/A	N/A	Flare Slope RT (%)	N/A
N/A	Flare Traversable LT?	N/A	N/A	Flare Traversable RT?	N/A
N/A	Landing Length (in)	N/A	N/A	DWS Provided?	N/A
N/A	Landing Width (in)	N/A	N/A	DWS Contrast?	N/A
N/A	Landing Slope (%)	N/A	N/A	DWS Length (in)	N/A
N/A	Landing X Slope (%)	N/A	N/A	DWS Full Width?	N/A
N/A	Landing Curb? (Y/N)	N/A	N/A	DWS Offset (in)	N/A
N/A	Shared Landing?	N/A			
N/A	Gutter Ponding?	N/A	N/A	Gutter Slope (%)	N/A
N/A	Gutter Lip Ht (in)	N/A	N/A	Gutter X Slope (%)	N/A
N/A	Painted X Walk1?	No	N/A	Painted X Walk2?	N/A
	X Walk 1 Direction	To E		X Walk 2 Direction	N/A
N/A	X Walk 1 Width (in)	N/A	N/A	X Walk 2 Width (in)	N/A
	X Walk 1 Slope (%)	1.3		X Walk 2 Slope (%)	N/A
	X Walk 1 X Slope (%)	3.3		X Walk 2 X Slope (%)	N/A

N/A	Ramp inside XWalk1?	N/A	N/A	Ramp inside XWalk2?	N/A
	Road Slope (%)	N/A	N/A	Clear Space?	N/A
	Road X Slope (%)	N/A	N/A	Clear Space to XWalk (in)	N/A
N/A	Any Obstructions?	N/A	N/A	Storm Grate/Utility Hazard?	N/A
	Obstruction Type			Storm Grate/Utility Type	
		N/A			N/A
			Yes	Surface Condition? (G/P)	Good

Remove & Replace Entire Ramp.

\$ 1850.00
