# Access Compliance Report

## Public Rights-of-Way

### (Curb Ramps)

Intersection ID: 12551	Main Street: BELVEDERE_AV	Cross Street: CLUB_RD	Location: NE
ADA ID: 85DCDA70310E	Ramp Type: PerpDiag	Initial Pass/Fail: Fail	Overall Compliance: No
Severity Score: 8.75			
Codes/Mitigation Info/Possible Solution		Field Measurements/Component Compliance

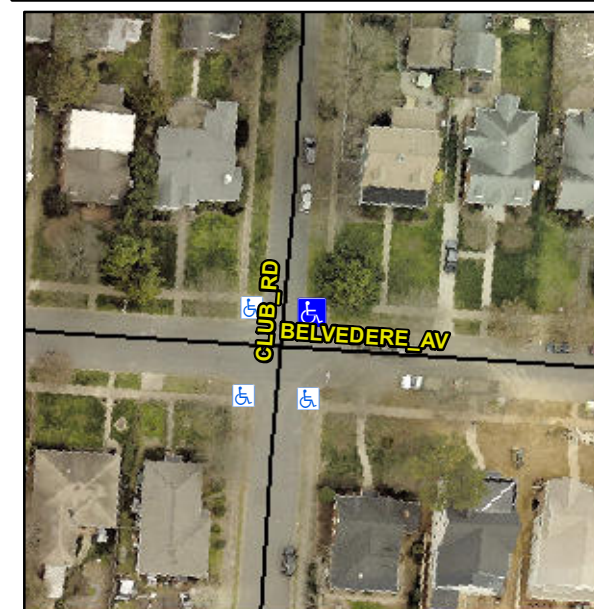
Compliance	Description	Data	Compliance	Description	Data
N/A	Ramp Length (in)	50.0	Yes	Ramp Slope (%)	6.3
No	Ramp Width (in)	38.0	Yes	Ramp XSlope (%)	0.2
N/A	Flare Type LT	N/A	N/A	Flare Type RT	N/A
N/A	Flare Slope LT (%)	N/A	N/A	Flare Slope RT (%)	N/A
N/A	Flare Traversable LT?	N/A	N/A	Flare Traversable RT?	N/A
N/A	Landing Length (in)	N/A	N/A	DWS Provided?	N/A
N/A	Landing Width (in)	N/A	N/A	DWS Contrast?	N/A
N/A	Landing Slope (%)	N/A	N/A	DWS Length (in)	N/A
N/A	Landing X Slope (%)	N/A	N/A	DWS Full Width?	N/A
N/A	Landing Curb? (Y/N)	N/A	N/A	DWS Offset (in)	N/A
N/A	Shared Landing?	N/A			
N/A	Gutter Ponding?	Yes	N/A	Gutter Slope (%)	N/A
N/A	Gutter Lip Ht (in)	N/A	N/A	Gutter X Slope (%)	N/A
N/A	Painted X Walk1?	No	N/A	Painted X Walk2?	No
	X Walk 1 Direction	To W		X Walk 2 Direction	To S
N/A	X Walk 1 Width (in)	N/A	N/A	X Walk 2 Width (in)	N/A
	X Walk 1 Slope (%)	2.8		X Walk 2 Slope (%)	2.3
	X Walk 1 X Slope (%)	2.5		X Walk 2 X Slope (%)	3.8

N/A	Ramp inside XWalk1?	N/A	N/A	Ramp inside XWalk2?	N/A
	Road Slope (%)	1.1	N/A	Clear Space?	N/A
	Road X Slope (%)	4.9	N/A	Clear Space to XWalk (in)	N/A
N/A	Any Obstructions?	N/A	N/A	Storm Grate/Utility Hazard?	N/A
	Obstruction Type			Storm Grate/Utility Type	
		N/A			N/A
		Yes		Surface Condition? (G/P)	Good

**Remove & Replace Curb Ramp With Two New Directional Ramps or Equivalent.**

**R304.5.1**
