# Access Compliance Report

## Public Rights-of-Way

### (Curb Ramps)

| Intersection ID: 30075 | Main Street: SOUTHWIND_DR | Cross Street: WOODLANDS_POINTE_DR | Location: W |

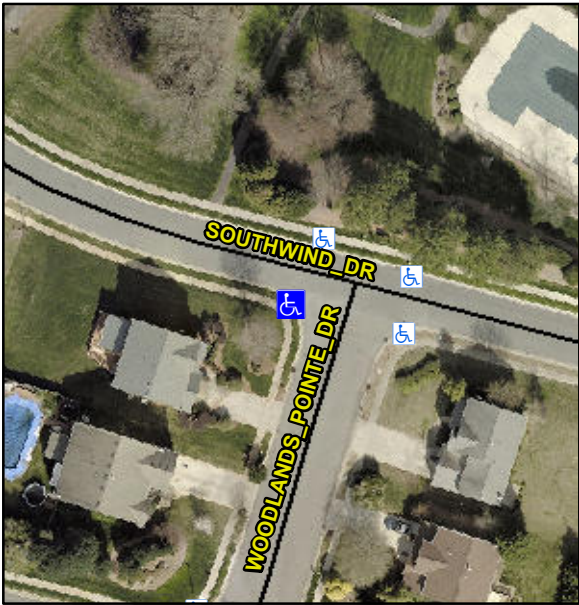
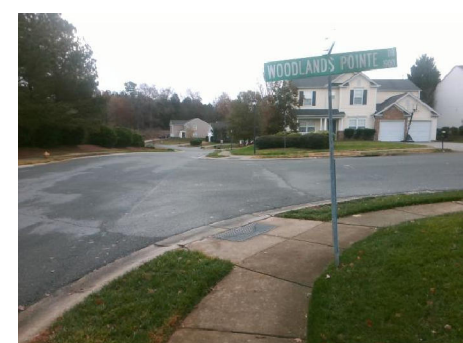
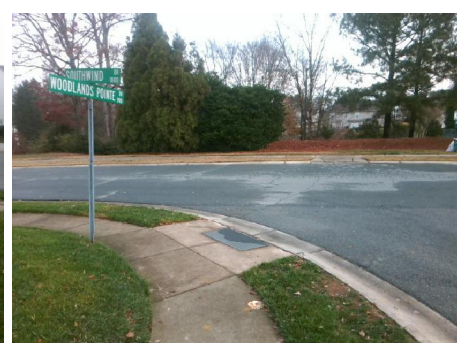
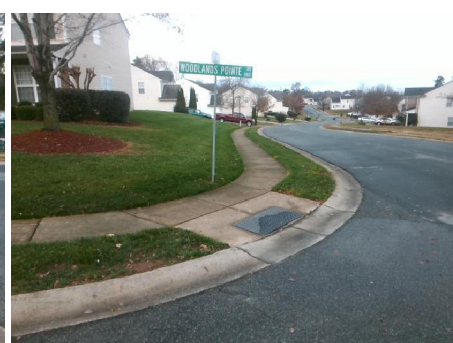
| ADA ID: 85E944A33602 | Ramp Type: PerpDiag | Initial Pass/Fail: Pass | Overall Compliance: No |

| Codes/Mitigation Info/Possible Solution | | | Field Measurements/Component Compliance | | | | | | | | | | | | | | | | | |
|---|---|--|---|--|--|---|--|--|---|--|--|---|--|--|---|--|--|---|--|--|
| | PROW/ADA: | | <b>Not Found, R304.5.3, R304.2.1, R305.2</b> | | | | | | | | | | | | | | | | | |
| | | | <b>Yes</b> | | | Ramp Width (in) | | | <b>48.0</b> | | | <b>No</b> | | | Ramp XSlope (%) | | | <b>2.2</b> | | |
| | | | <b>No</b> | | | Landing Length (in) | | | <b>41.0</b> | | | <b>Yes</b> | | | DWS Provided? | | | <b>Yes</b> | | |
| | | | <b>N/A</b> | | | Landing Curb? (Y/N) | | | <b>No</b> | | | <b>No</b> | | | DWS Offset (in) | | | <b>3.0</b> | | |

| Codes/Mitigation Info/Possible Solution | | | Field Measurements/Component Compliance | | | | | | | | | | | | | | | | | |
|---|---|--|---|--|--|---|--|--|---|--|--|---|--|--|---|--|--|---|--|--|
| | Possible Solutions: | | <b>Remove &amp; Replace Curb Ramp With Two New Directional Ramps or Equivalent.</b> | | | | | | | | | | | | | | | | | |
| | Total Cost: | | <b>\$ 3200.00</b> | | | | | | | | | | | | | | | | | |
