Access Compliance Report

Public Rights-of-Way

(Curb Ramps)

Intersection ID: 10040074	Main Street: TUCKASEEGEE_RD	Cross Street: N/A	Location: S
ADA ID: 85ED28FCFBD6	Ramp Type: Perp	Initial Pass/Fail: Fail	Overall Compliance: No
Severity Score: 25			
Codes/Mitigation Info/Possible Solution		Field Measurements/Component Compliance

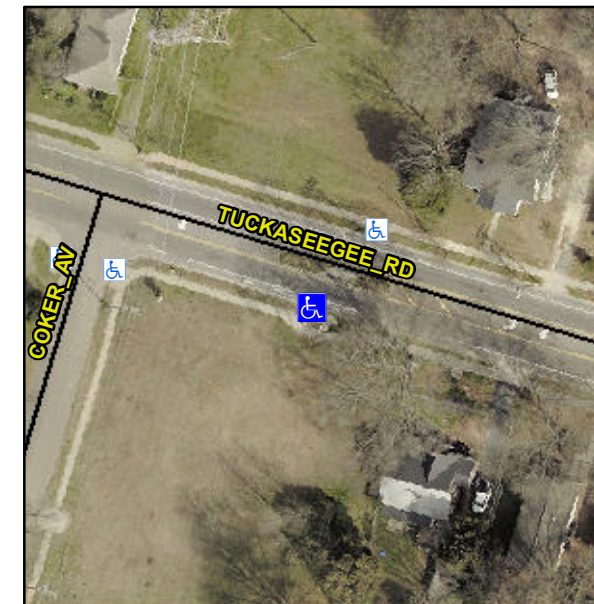
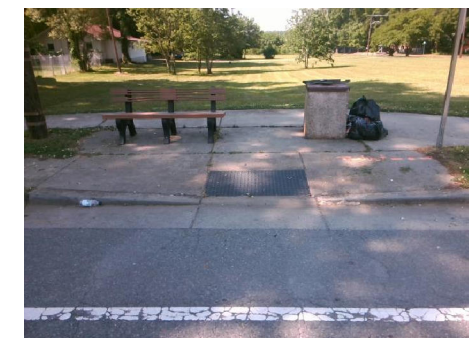
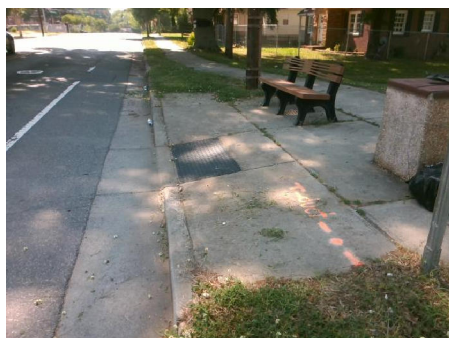
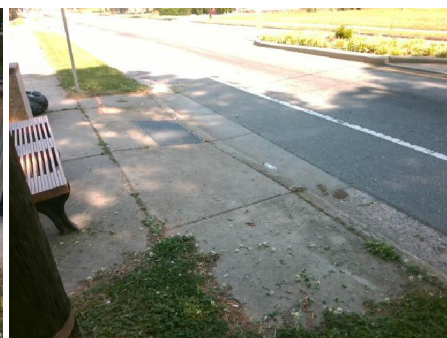
Not Found, R304.2.2

Compliance	Description	Data	Compliance	Description	Data
N/A	Ramp Length (in)	48.0	No	Ramp Slope (%)	13.4
Yes	Ramp Width (in)	48.0	Yes	Ramp XSlope (%)	1.3
N/A	Flare Type LT	N/A	N/A	Flare Type RT	N/A
N/A	Flare Slope LT (%)	N/A	N/A	Flare Slope RT (%)	N/A
N/A	Flare Traversable LT?	N/A	N/A	Flare Traversable RT?	N/A
N/A	Landing Length (in)	N/A	N/A	DWS Provided?	N/A
N/A	Landing Width (in)	N/A	N/A	DWS Contrast?	N/A
N/A	Landing Slope (%)	N/A	N/A	DWS Length (in)	N/A
N/A	Landing X Slope (%)	N/A	N/A	DWS Full Width?	N/A
N/A	Landing Curb? (Y/N)	N/A	N/A	DWS Offset (in)	N/A
N/A	Shared Landing?	N/A			
N/A	Gutter Ponding?	N/A	N/A	Gutter Slope (%)	N/A
N/A	Gutter Lip Ht (in)	N/A	N/A	Gutter X Slope (%)	N/A
N/A	Painted X Walk1?	No	N/A	Painted X Walk2?	N/A
	X Walk 1 Direction	To NE		X Walk 2 Direction	N/A
N/A	X Walk 1 Width (in)	N/A	N/A	X Walk 2 Width (in)	N/A
	X Walk 1 Slope (%)	6.0		X Walk 2 Slope (%)	N/A
	X Walk 1 X Slope (%)	2.2		X Walk 2 X Slope (%)	N/A

N/A	Ramp inside XWalk1?	N/A	N/A	Ramp inside XWalk2?	N/A
	Road Slope (%)	N/A	N/A	Clear Space?	N/A
	Road X Slope (%)	N/A	N/A	Clear Space to XWalk (in)	N/A
N/A	Any Obstructions?	N/A	N/A	Storm Grate/Utility Hazard?	N/A
	Obstruction Type			Storm Grate/Utility Type	
		N/A			N/A
			Yes	Surface Condition? (G/P)	Good

Possible Solutions:

Remove & Replace Entire Ramp.
