Access Compliance Report

Public Rights-of-Way

(Curb Ramps)

Intersection ID: 7486	Main Street: TRYON_ST	Cross Street: OWEN_ST	Location: SE
ADA ID: 85F2E1A82F54	Ramp Type: Perp	Initial Pass/Fail: Fail	Overall Compliance: No
Severity Score: 12.5			
Codes/Mitigation Info/Possible Solution		Field Measurements/Component Compliance

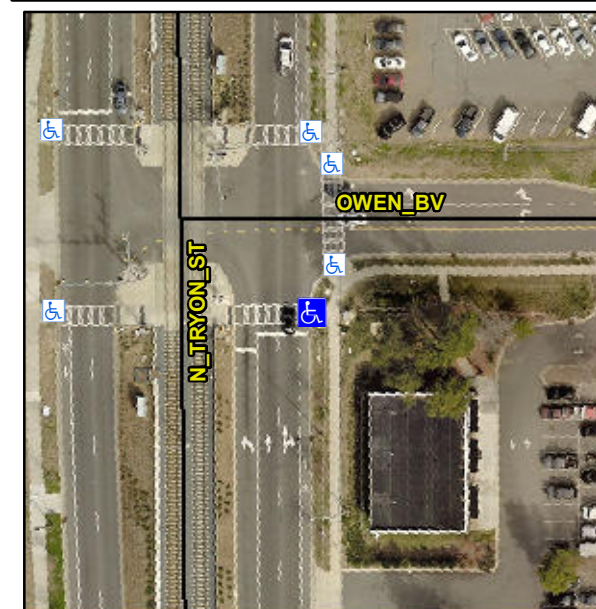
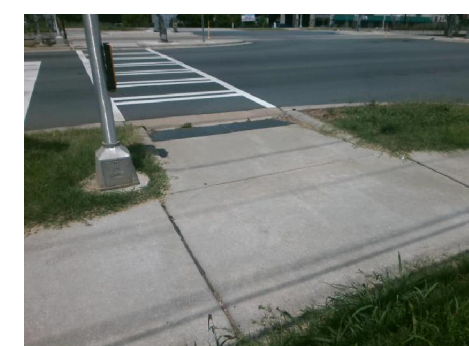
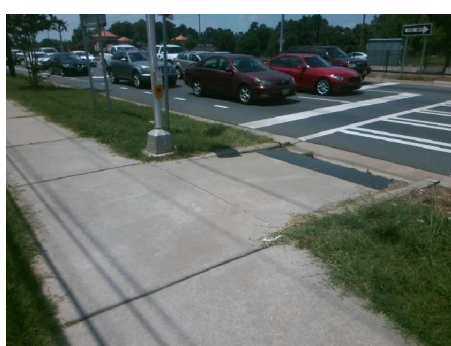
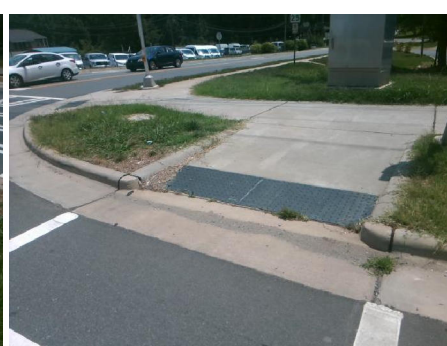
Not Found, R304.2.2

Compliance	Description	Data	Compliance	Description	Data
N/A	Ramp Length (in)	95.0	No	Ramp Slope (%)	9.1
Yes	Ramp Width (in)	94.0	Yes	Ramp XSlope (%)	0.5
N/A	Flare Type LT	N/A	N/A	Flare Type RT	N/A
N/A	Flare Slope LT (%)	N/A	N/A	Flare Slope RT (%)	N/A
N/A	Flare Traversable LT?	N/A	N/A	Flare Traversable RT?	N/A
N/A	Landing Length (in)	N/A	N/A	DWS Provided?	N/A
N/A	Landing Width (in)	N/A	N/A	DWS Contrast?	N/A
N/A	Landing Slope (%)	N/A	N/A	DWS Length (in)	N/A
N/A	Landing X Slope (%)	N/A	N/A	DWS Full Width?	N/A
N/A	Landing Curb? (Y/N)	N/A	N/A	DWS Offset (in)	N/A
N/A	Shared Landing?	N/A			
N/A	Gutter Ponding?	N/A	N/A	Gutter Slope (%)	N/A
N/A	Gutter Lip Ht (in)	N/A	N/A	Gutter X Slope (%)	N/A
N/A	Painted X Walk1?	Yes	N/A	Painted X Walk2?	N/A
	X Walk 1 Direction	To W		X Walk 2 Direction	N/A
N/A	X Walk 1 Width (in)	105.0	N/A	X Walk 2 Width (in)	N/A
	X Walk 1 Slope (%)	2.8		X Walk 2 Slope (%)	N/A
	X Walk 1 X Slope (%)	0.3		X Walk 2 X Slope (%)	N/A

N/A	Ramp inside XWalk1?	Yes	N/A	Ramp inside XWalk2?	N/A
	Road Slope (%)	N/A	N/A	Clear Space?	N/A
	Road X Slope (%)	N/A	N/A	Clear Space to XWalk (in)	N/A
N/A	Any Obstructions?	N/A	N/A	Storm Grate/Utility Hazard?	N/A
	Obstruction Type			Storm Grate/Utility Type	
		N/A			N/A
		Yes		Surface Condition? (G/P)	Good

Possible Solutions:

Remove & Replace Entire Ramp.
