Access Compliance Report

Public Rights-of-Way

Intersection ID: N/A	Main Street: ENDAVEN LN	Cross Street: NORTH COMMUNITY HOUSE RD	Location: SW
ADA ID: 85FF016C3A70	Ramp Type: Perp	Initial Pass/Fail: Fail	Overall Compliance: No
Severity Score: 13.75			
Codes/Mitigation Info/Possible Solution		Field Measurements/Component Compliance

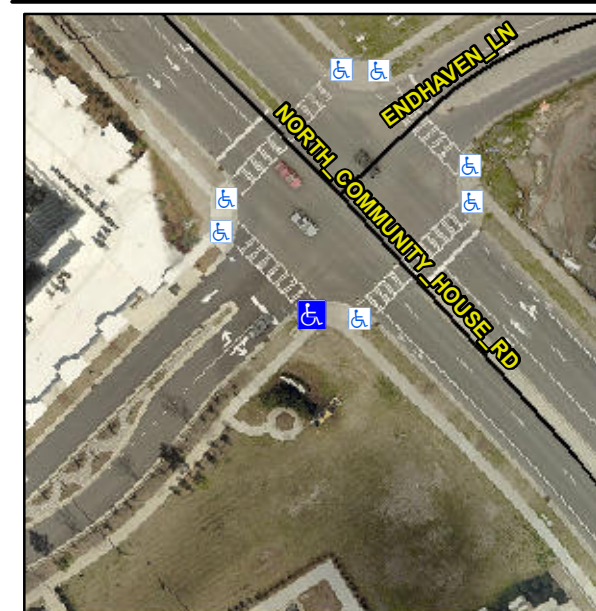
Compliance	Description	Data	Compliance	Description	Data
N/A	Ramp Length (in)	70.5	No	Ramp Slope (%)	9.9
Yes	Ramp Width (in)	48.0	No	Ramp XSlope (%)	4.4
N/A	Flare Type LT	N/A	N/A	Flare Type RT	N/A
N/A	Flare Slope LT (%)	N/A	N/A	Flare Slope RT (%)	N/A
N/A	Flare Traversable LT?	N/A	N/A	Flare Traversable RT?	N/A
N/A	Landing Length (in)	N/A	N/A	DWS Provided?	N/A
N/A	Landing Width (in)	N/A	N/A	DWS Contrast?	N/A
N/A	Landing Slope (%)	N/A	N/A	DWS Length (in)	N/A
N/A	Landing X Slope (%)	N/A	N/A	DWS Full Width?	N/A
N/A	Landing Curb? (Y/N)	N/A	N/A	DWS Offset (in)	N/A
N/A	Shared Landing?	N/A			
N/A	Gutter Ponding?	N/A	N/A	Gutter Slope (%)	N/A
N/A	Gutter Lip Ht (in)	N/A	N/A	Gutter X Slope (%)	N/A
N/A	Painted X Walk1?	Yes	N/A	Painted X Walk2?	N/A
	X Walk 1 Direction	To NW		X Walk 2 Direction	N/A
N/A	X Walk 1 Width (in)	110.0	N/A	X Walk 2 Width (in)	N/A
	X Walk 1 Slope (%)	0.6		X Walk 2 Slope (%)	N/A
	X Walk 1 X Slope (%)	3.4		X Walk 2 X Slope (%)	N/A

N/A	Ramp inside XWalk1?	Yes	N/A	Ramp inside XWalk2?	N/A
	Road Slope (%)	N/A	N/A	Clear Space?	N/A
	Road X Slope (%)	N/A	N/A	Clear Space to XWalk (in)	N/A
N/A	Any Obstructions?	N/A	N/A	Storm Grate/Utility Hazard?	N/A
	Obstruction Type			Storm Grate/Utility Type	
		N/A			N/A
		Yes		Surface Condition? (G/P)	Good

Possible Solutions:

Remove & Replace Entire Ramp.

R304.2.2, R304.5.3
