Access Compliance Report

Public Rights-of-Way

(Curb Ramps)

Intersection ID: 12972	Main Street: HAMORTON_PL	Cross Street: THOMAS_AV	Location: SE
ADA ID: 86021927424E	Ramp Type: PerpDiag	Initial Pass/Fail: Fail	Overall Compliance: No
Codes/Mitigation Info/Possible Solution		Field Measurements/Component Compliance	
Severity Score: 8.75

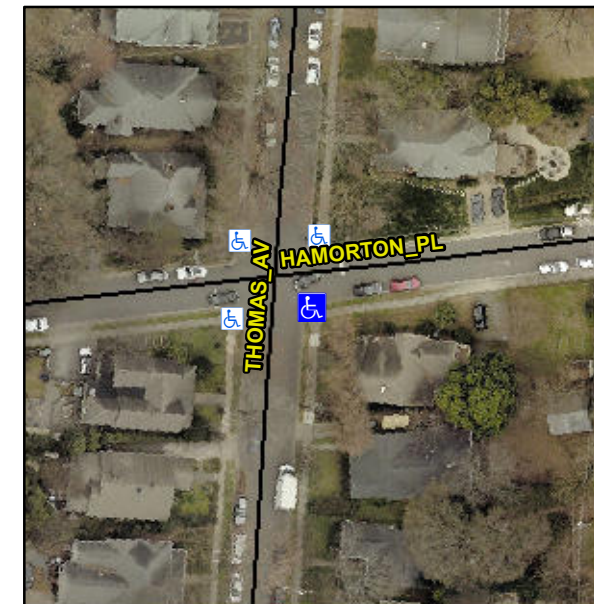
Not Found, R304.5.1

Compliance	Description	Data	Compliance	Description	Data
N/A	Ramp Length (in)	36.5	Yes	Ramp Slope (%)	7.5
No	Ramp Width (in)	47.0	Yes	Ramp XSlope (%)	1.0
N/A	Flare Type LT	N/A	N/A	Flare Type RT	N/A
N/A	Flare Slope LT (%)	N/A	N/A	Flare Slope RT (%)	N/A
N/A	Flare Traversable LT?	N/A	N/A	Flare Traversable RT?	N/A
N/A	Landing Length (in)	N/A	N/A	DWS Provided?	N/A
N/A	Landing Width (in)	N/A	N/A	DWS Contrast?	N/A
N/A	Landing Slope (%)	N/A	N/A	DWS Length (in)	N/A
N/A	Landing X Slope (%)	N/A	N/A	DWS Full Width?	N/A
N/A	Landing Curb? (Y/N)	N/A	N/A	DWS Offset (in)	N/A
N/A	Shared Landing?	N/A			
N/A	Gutter Ponding?	Yes	N/A	Gutter Slope (%)	N/A
N/A	Gutter Lip Ht (in)	2.5	N/A	Gutter X Slope (%)	N/A
N/A	Painted X Walk1?	No	N/A	Painted X Walk2?	No
	X Walk 1 Direction	To N		X Walk 2 Direction	To W
N/A	X Walk 1 Width (in)	N/A	N/A	X Walk 2 Width (in)	N/A
	X Walk 1 Slope (%)	2.1		X Walk 2 Slope (%)	4.8
	X Walk 1 X Slope (%)	3.1		X Walk 2 X Slope (%)	1.6

N/A	Ramp inside XWalk1?	N/A	N/A	Ramp inside XWalk2?	N/A
	Road Slope (%)	0.8	N/A	Clear Space?	N/A
	Road X Slope (%)	0.9	N/A	Clear Space to XWalk (in)	N/A
N/A	Any Obstructions?	N/A	N/A	Storm Grate/Utility Hazard?	N/A
	Obstruction Type			Storm Grate/Utility Type	
		N/A			N/A
		Yes		Surface Condition? (G/P)	Good

Possible Solutions:

Remove & Replace Curb Ramp With Two New Directional Ramps or Equivalent.
