Access Compliance Report

Public Rights-of-Way

(Curb Ramps)

Intersection ID: 10038774	Main Street: STEELE_CREEK_RD	Cross Street: N/A	Location: NW
ADA ID: 860F3338E3A4	Ramp Type: Perp	Initial Pass/Fail: Fail	Overall Compliance: No
Severity Score: 12.5			
Codes/Mitigation Info/Possible Solution		Field Measurements/Component Compliance

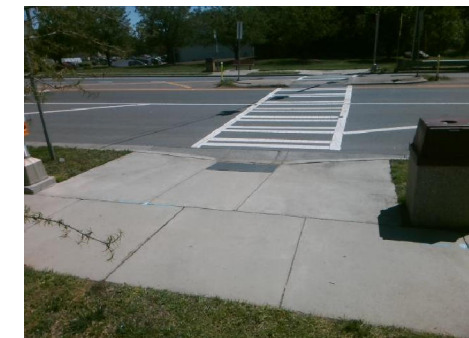
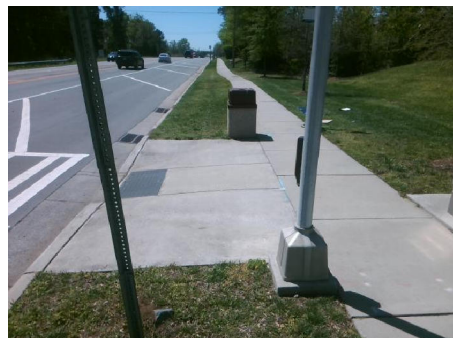
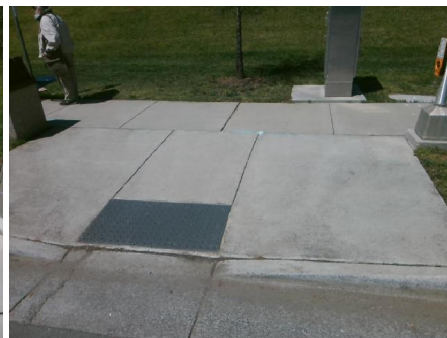
Not Found, R304.2.2

Compliance	Description	Data	Compliance	Description	Data
N/A	Ramp Length (in)	94.0	No	Ramp Slope (%)	10.0
Yes	Ramp Width (in)	48.0	Yes	Ramp XSlope (%)	1.2
N/A	Flare Type LT	N/A	N/A	Flare Type RT	N/A
N/A	Flare Slope LT (%)	N/A	N/A	Flare Slope RT (%)	N/A
N/A	Flare Traversable LT?	N/A	N/A	Flare Traversable RT?	N/A
N/A	Landing Length (in)	N/A	N/A	DWS Provided?	N/A
N/A	Landing Width (in)	N/A	N/A	DWS Contrast?	N/A
N/A	Landing Slope (%)	N/A	N/A	DWS Length (in)	N/A
N/A	Landing X Slope (%)	N/A	N/A	DWS Full Width?	N/A
N/A	Landing Curb? (Y/N)	N/A	N/A	DWS Offset (in)	N/A
N/A	Shared Landing?	N/A			
N/A	Gutter Ponding?	N/A	N/A	Gutter Slope (%)	N/A
N/A	Gutter Lip Ht (in)	N/A	N/A	Gutter X Slope (%)	N/A
N/A	Painted X Walk1?	Yes	N/A	Painted X Walk2?	N/A
	X Walk 1 Direction	To SE		X Walk 2 Direction	N/A
N/A	X Walk 1 Width (in)	110.0	N/A	X Walk 2 Width (in)	N/A
	X Walk 1 Slope (%)	3.1		X Walk 2 Slope (%)	N/A
	X Walk 1 X Slope (%)	0.2		X Walk 2 X Slope (%)	N/A

N/A	Ramp inside XWalk1?	Yes	N/A	Ramp inside XWalk2?	N/A
	Road Slope (%)	N/A	N/A	Clear Space?	N/A
	Road X Slope (%)	N/A	N/A	Clear Space to XWalk (in)	N/A
N/A	Any Obstructions?	N/A	N/A	Storm Grate/Utility Hazard?	N/A
	Obstruction Type			Storm Grate/Utility Type	
		N/A			N/A
		Yes		Surface Condition? (G/P)	Good

Remove & Replace Entire Ramp.
