## **Access Compliance Report Public Rights-of-Way** (Curb Ramps)

Intersection ID: 10020730 Main Street: BEATTIES FORD RD Cross Street: N/A Location: NE Initial Pass/Fail: Pass **Overall Compliance: No Severity Score:** 0 ADA ID: 8614D78F24EB Ramp Type: Combination1

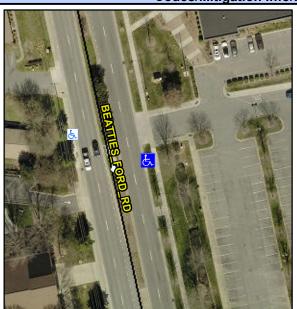
Compliance Description Possible Solutions: N/A Remove & Replace Entire Ramp. Yes Yes Yes N/A Yes Surveyor Notes: Yes N/A N/A N/A Yes Yes PROW/ADA: Yes **Not Found** Yes N/A N/A Yes Yes N/A
