# Access Compliance Report

## Public Rights-of-Way

### (Curb Ramps)

| Intersection ID: 16072 | Main Street: MONROE_RD | Cross Street: RICHLAND_DR | Location: SW |

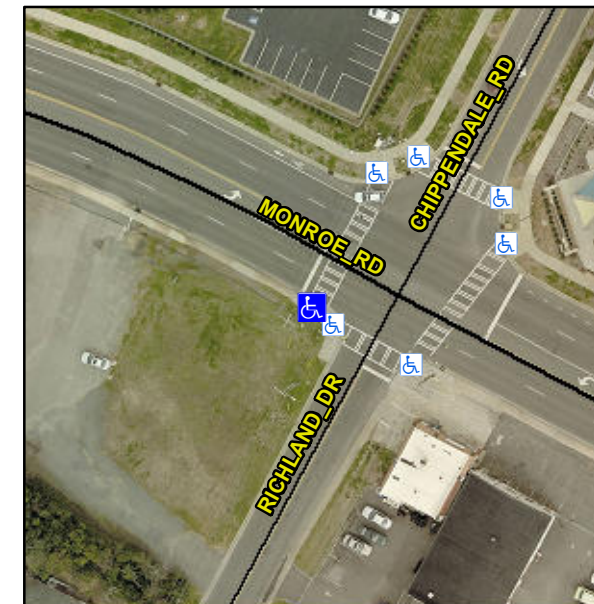
**RT RP < 5%**

**R304.5.3, R304.2.1, R304.2.2-Perp,**  
**R304.3.2-Para, R304.5.4**

| Compliance | Description | Data | Compliance | Description | Data |
|---|---|---|---|---|---|
| No | Ramp XSlope LT (%) | 2.1 | Yes | Ramp XSlope RT (%) | 0.7 |
| No | Landing Length (in) | N/A | Yes | DWS Provided? | Yes |
| Yes | Gutter Ponding? | No | No | Gutter Slope (%) | 7.8 |
| Yes | Gutter Lip Ht (in) | 0.0 | No | Gutter X Slope (%) | 2.2 |

**Remove & Replace Entire Ramp.**  
**Remove & Replace Gutter.**
