Access Compliance Report

Public Rights-of-Way

(Curb Ramps)

Intersection ID: 21800	Main Street: MILL_POND_RD	Cross Street: SCHOOL_HOUSE_LN	Location: S
ADA ID: 86171D4B8824	Ramp Type: PerpDiag	Initial Pass/Fail: Fail	Overall Compliance: No
		Severity Score: 22.5

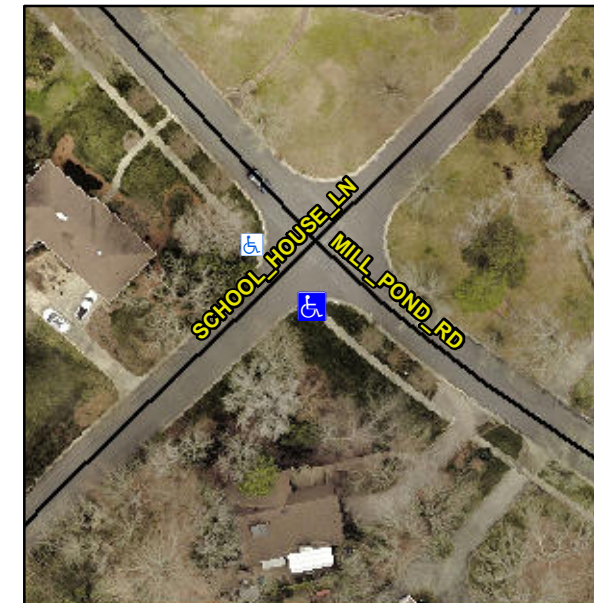
Not Found, R304.5.1, R304.2.2, R304.5.3

Compliance	Description	Data	Compliance	Description	Data
N/A	Ramp Length (in)	73.0	No	Ramp Slope (%)	10.2
No	Ramp Width (in)	45.0	No	Ramp XSlope (%)	4.5
N/A	Flare Type LT	N/A	N/A	Flare Type RT	N/A
N/A	Flare Slope LT (%)	N/A	N/A	Flare Slope RT (%)	N/A
N/A	Flare Traversable LT?	N/A	N/A	Flare Traversable RT?	N/A
N/A	Landing Length (in)	N/A	N/A	DWS Provided?	N/A
N/A	Landing Width (in)	N/A	N/A	DWS Contrast?	N/A
N/A	Landing Slope (%)	N/A	N/A	DWS Length (in)	N/A
N/A	Landing X Slope (%)	N/A	N/A	DWS Full Width?	N/A
N/A	Landing Curb? (Y/N)	N/A	N/A	DWS Offset (in)	N/A
N/A	Shared Landing?	N/A			
N/A	Gutter Ponding?	N/A	N/A	Gutter Slope (%)	N/A
N/A	Gutter Lip Ht (in)	N/A	N/A	Gutter X Slope (%)	N/A
N/A	Painted X Walk1?	No	N/A	Painted X Walk2?	No
	X Walk 1 Direction	To NE		X Walk 2 Direction	To NW
N/A	X Walk 1 Width (in)	N/A	N/A	X Walk 2 Width (in)	N/A
	X Walk 1 Slope (%)	6.0		X Walk 2 Slope (%)	2.5
	X Walk 1 X Slope (%)	1.0		X Walk 2 X Slope (%)	5.5

N/A	Ramp inside XWalk1?	N/A	N/A	Ramp inside XWalk2?	N/A
	Road Slope (%)	4.2	N/A	Clear Space?	N/A
	Road X Slope (%)	5.9	N/A	Clear Space to XWalk (in)	N/A
N/A	Any Obstructions?	N/A	N/A	Storm Grate/Utility Hazard?	N/A
	Obstruction Type			Storm Grate/Utility Type	
		N/A			N/A
			Yes	Surface Condition? (G/P)	Good

Remove & Replace Curb Ramp With Two New Directional Ramps or Equivalent.

Total Cost: \$ 3200.00
