Access Compliance Report

Public Rights-of-Way

(Curb Ramps)

Intersection ID: 45064	Main Street: CHALKSTONE_RD	Cross Street: ESCAFLWNE_AV	Location: NE
ADA ID: 8625001ABB6E	Ramp Type: BlendTrans1	Initial Pass/Fail: Fail	Overall Compliance: No
		Severity Score: 8.75

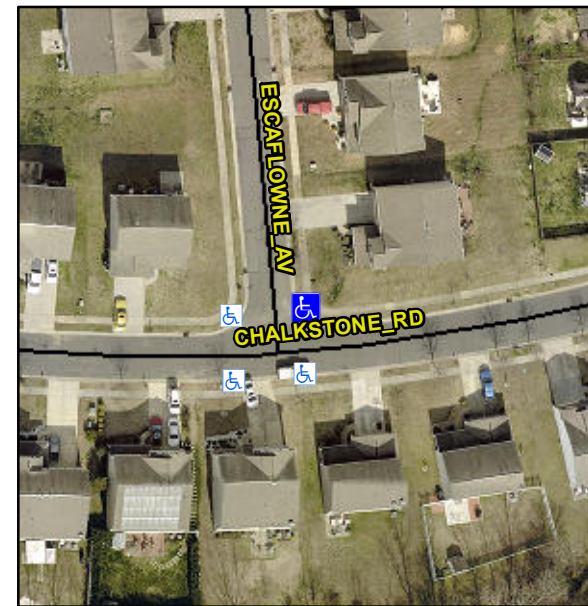
Not Found, R304.5.1

Compliance	Description	Data	Compliance	Description	Data
N/A	Ramp Length (in)	47.0	Yes	BlendTrans Slope (%)	4.5
No	Ramp Width (in)	41.0	Yes	BlendTrans XSlope (%)	1.0
N/A	Flare Type LT	N/A	N/A	Flare Type RT	N/A
N/A	Flare Slope LT (%)	N/A	N/A	Flare Slope RT (%)	N/A
N/A	Flare Traversable LT?	N/A	N/A	Flare Traversable RT?	N/A
N/A	Landing Length (in)	N/A	N/A	DWS Provided?	N/A
N/A	Landing Width (in)	N/A	N/A	DWS Contrast?	N/A
N/A	Landing Slope (%)	N/A	N/A	DWS Length (in)	N/A
N/A	Landing X Slope (%)	N/A	N/A	DWS Full Width?	N/A
N/A	Landing Curb? (Y/N)	N/A	N/A	DWS Offset (in)	N/A
N/A	Shared Landing?	N/A			
N/A	Gutter Ponding?	N/A	N/A	Gutter Slope (%)	N/A
N/A	Gutter Lip Ht (in)	N/A	N/A	Gutter X Slope (%)	N/A
N/A	Painted X Walk1?	No	N/A	Painted X Walk2?	No
	X Walk 1 Direction	To W		X Walk 2 Direction	To S
	X Walk 1 Width (in)	N/A		X Walk 2 Width (in)	N/A
	X Walk 1 Slope (%)	0.1		X Walk 2 Slope (%)	4.3
	X Walk 1 X Slope (%)	0.3		X Walk 2 X Slope (%)	0.4

N/A	Ramp inside XWalk1?	N/A	N/A	Ramp inside XWalk2?	N/A
	Road Slope (%)	0.7		Clear Space?	N/A
	Road X Slope (%)	0.5	N/A	Clear Space to XWalk (in)	N/A
N/A	Any Obstructions?	N/A	N/A	Storm Grate/Utility Hazard?	N/A
	Obstruction Type			Storm Grate/Utility Type	
		N/A			N/A
			Yes	Surface Condition? (G/P)	Good
			No	Curb Slope (%)	8.5

Possible Solutions:

Remove & Replace Curb Ramp With Two New Directional Ramps or Equivalent.
