# Access Compliance Report

## Public Rights-of-Way

### (Curb Ramps)

| Intersection ID: 50512 | Main Street: EVERSFIELD_LN | Cross Street: MERIDALE_CROSSING_DR | Location: S |

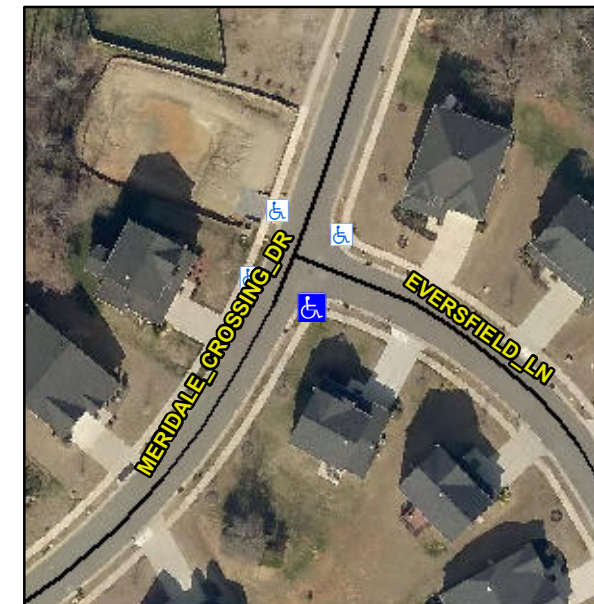
**Not Found, R304.5.1, R304.2.2, R304.5.3**

| Compliance | Description | Data | Compliance | Description | Data |
|---|---|---|---|---|---|
| N/A | Ramp Length (in) | 47.0 | No | Ramp Slope (%) | 10.2 |
| No | Ramp Width (in) | 47.5 | No | Ramp XSlope (%) | 2.2 |

**Remove & Replace Curb Ramp With Two New Directional Ramps or Equivalent.**
