Access Compliance Report

Public Rights-of-Way

(Curb Ramps)

Intersection ID: 10024872	Main Street: DEWITT_LN	Cross Street: N/A	Location: SE
ADA ID: 864FFBC8248B	Ramp Type: Perp	Initial Pass/Fail: Fail	Overall Compliance: No
Severity Score: 22.5			
Codes/Mitigation Info/Possible Solution		Field Measurements/Component Compliance

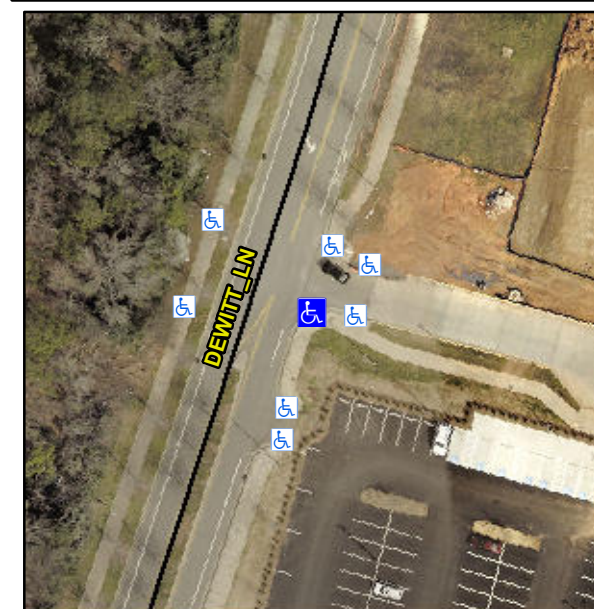
Not Found, R304.5.1, R304.2.2, R304.5.3

Compliance	Description	Data	Compliance	Description	Data
N/A	Ramp Length (in)	96.0	No	Ramp Slope (%)	9.8
No	Ramp Width (in)	46.0	No	Ramp XSlope (%)	3.2
N/A	Flare Type LT	N/A	N/A	Flare Type RT	N/A
N/A	Flare Slope LT (%)	N/A	N/A	Flare Slope RT (%)	N/A
N/A	Flare Traversable LT?	N/A	N/A	Flare Traversable RT?	N/A
N/A	Landing Length (in)	N/A	N/A	DWS Provided?	N/A
N/A	Landing Width (in)	N/A	N/A	DWS Contrast?	N/A
N/A	Landing Slope (%)	N/A	N/A	DWS Length (in)	N/A
N/A	Landing X Slope (%)	N/A	N/A	DWS Full Width?	N/A
N/A	Landing Curb? (Y/N)	N/A	N/A	DWS Offset (in)	N/A
N/A	Shared Landing?	N/A			
N/A	Gutter Ponding?	N/A	N/A	Gutter Slope (%)	N/A
N/A	Gutter Lip Ht (in)	N/A	N/A	Gutter X Slope (%)	N/A
N/A	Painted X Walk1?	No	N/A	Painted X Walk2?	N/A
	X Walk 1 Direction	To W		X Walk 2 Direction	N/A
N/A	X Walk 1 Width (in)	N/A	N/A	X Walk 2 Width (in)	N/A
	X Walk 1 Slope (%)	0.5		X Walk 2 Slope (%)	N/A
	X Walk 1 X Slope (%)	1.3		X Walk 2 X Slope (%)	N/A

N/A	Ramp inside XWalk1?	N/A	N/A	Ramp inside XWalk2?	N/A
	Road Slope (%)	N/A	N/A	Clear Space?	N/A
	Road X Slope (%)	N/A	N/A	Clear Space to XWalk (in)	N/A
N/A	Any Obstructions?	N/A	N/A	Storm Grate/Utility Hazard?	N/A
	Obstruction Type			Storm Grate/Utility Type	
		N/A			N/A
			Yes	Surface Condition? (G/P)	Good

Possible Solutions:

Remove & Replace Entire Ramp.
