Access Compliance Report

Public Rights-of-Way

(Curb Ramps)

Intersection ID: 20185	Main Street: FAIRVIEW_RD	Cross Street: PIEDMONT_ROW_DR	Location: NE
ADA ID: 86526991D105	Ramp Type: Perp	Initial Pass/Fail: Fail	Overall Compliance: No
		Severity Score: 12.5

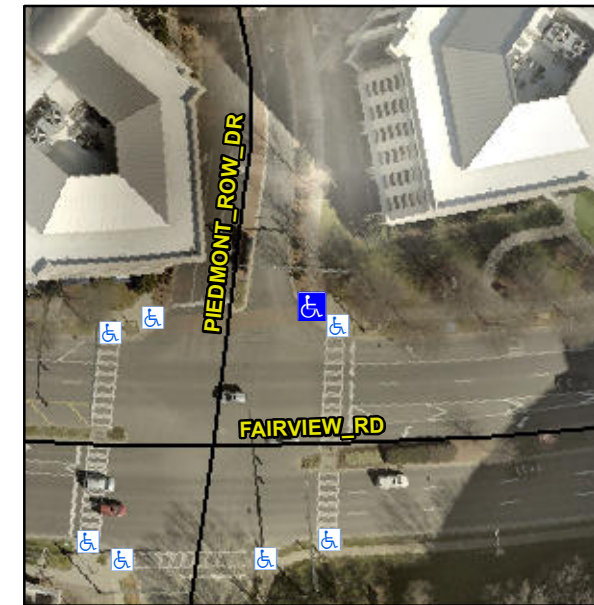
Not Found, R304.2.2

Compliance	Description	Data	Compliance	Description	Data
N/A	Ramp Length (in)	94.0	No	Ramp Slope (%)	10.1
Yes	Ramp Width (in)	48.0	Yes	Ramp XSlope (%)	0.4
N/A	Flare Type LT	N/A	N/A	Flare Type RT	N/A
N/A	Flare Slope LT (%)	N/A	N/A	Flare Slope RT (%)	N/A
N/A	Flare Traversable LT?	N/A	N/A	Flare Traversable RT?	N/A
N/A	Landing Length (in)	N/A	N/A	DWS Provided?	N/A
N/A	Landing Width (in)	N/A	N/A	DWS Contrast?	N/A
N/A	Landing Slope (%)	N/A	N/A	DWS Length (in)	N/A
N/A	Landing X Slope (%)	N/A	N/A	DWS Full Width?	N/A
N/A	Landing Curb? (Y/N)	N/A	N/A	DWS Offset (in)	N/A
N/A	Shared Landing?	N/A			
N/A	Gutter Ponding?	N/A	N/A	Gutter Slope (%)	N/A
N/A	Gutter Lip Ht (in)	N/A	N/A	Gutter X Slope (%)	N/A
N/A	Painted X Walk1?	Yes	N/A	Painted X Walk2?	N/A
	X Walk 1 Direction	To NW		X Walk 2 Direction	N/A
N/A	X Walk 1 Width (in)	110.0	N/A	X Walk 2 Width (in)	N/A
	X Walk 1 Slope (%)	3.3		X Walk 2 Slope (%)	N/A
	X Walk 1 X Slope (%)	2.8		X Walk 2 X Slope (%)	N/A

N/A	Ramp inside XWalk1?	Yes	N/A	Ramp inside XWalk2?	N/A
	Road Slope (%)	N/A	N/A	Clear Space?	N/A
	Road X Slope (%)	N/A	N/A	Clear Space to XWalk (in)	N/A
N/A	Any Obstructions?	N/A	N/A	Storm Grate/Utility Hazard?	N/A
	Obstruction Type			Storm Grate/Utility Type	
		N/A			N/A
			Yes	Surface Condition? (G/P)	Good

Possible Solutions:

Remove & Replace Entire Ramp.
