Access Compliance Report

Public Rights-of-Way

(Curb Ramps)

Intersection ID: 27397	Main Street: ELM_LN	Cross Street: BALLANTYNE_COMMONS_PY	Location: NW
ADA ID: 8655BDF13CDD	Ramp Type: Perp	Initial Pass/Fail: Fail	Overall Compliance: No
Severity Score: 12.5			
Codes/Mitigation Info/Possible Solution		Field Measurements/Component Compliance

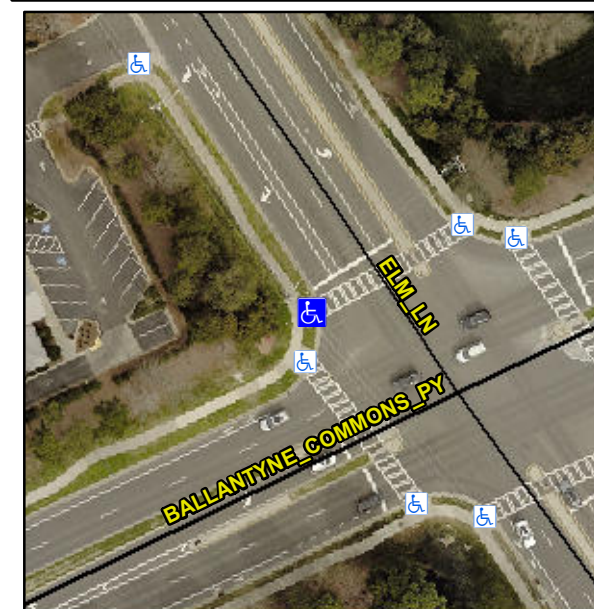
Not Found, R304.2.2

Compliance	Description	Data	Compliance	Description	Data
N/A	Ramp Length (in)	84.0	No	Ramp Slope (%)	8.6
Yes	Ramp Width (in)	48.0	Yes	Ramp XSlope (%)	1.2
N/A	Flare Type LT	N/A	N/A	Flare Type RT	N/A
N/A	Flare Slope LT (%)	N/A	N/A	Flare Slope RT (%)	N/A
N/A	Flare Traversable LT?	N/A	N/A	Flare Traversable RT?	N/A
N/A	Landing Length (in)	N/A	N/A	DWS Provided?	N/A
N/A	Landing Width (in)	N/A	N/A	DWS Contrast?	N/A
N/A	Landing Slope (%)	N/A	N/A	DWS Length (in)	N/A
N/A	Landing X Slope (%)	N/A	N/A	DWS Full Width?	N/A
N/A	Landing Curb? (Y/N)	N/A	N/A	DWS Offset (in)	N/A
N/A	Shared Landing?	N/A			
N/A	Gutter Ponding?	N/A	N/A	Gutter Slope (%)	N/A
N/A	Gutter Lip Ht (in)	N/A	N/A	Gutter X Slope (%)	N/A
N/A	Painted X Walk1?	Yes	N/A	Painted X Walk2?	N/A
	X Walk 1 Direction	To NE		X Walk 2 Direction	N/A
N/A	X Walk 1 Width (in)	112.0	N/A	X Walk 2 Width (in)	N/A
	X Walk 1 Slope (%)	3.6		X Walk 2 Slope (%)	N/A
	X Walk 1 X Slope (%)	1.6		X Walk 2 X Slope (%)	N/A

Possible Solutions:

Remove & Replace Entire Ramp.

Total Cost: \$ 1850.00
