Access Compliance Report

Public Rights-of-Way

(Curb Ramps)

Intersection ID: 4457	Main Street: OLD_STATESVILLE_RD	Cross Street: LABORDE_AV	Location: NW
ADA ID: 866894BCA192	Ramp Type: Perp	Initial Pass/Fail: Fail	Overall Compliance: No
Severity Score: 48.75			
Codes/Mitigation Info/Possible Solution		Field Measurements/Component Compliance

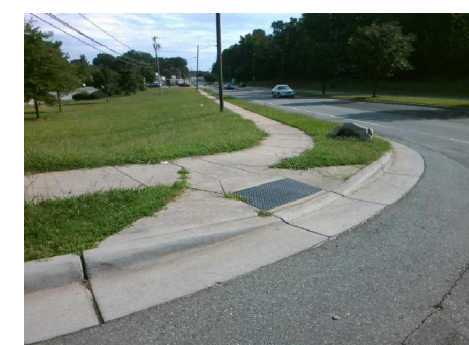
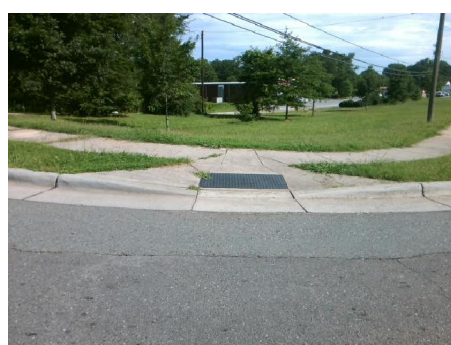
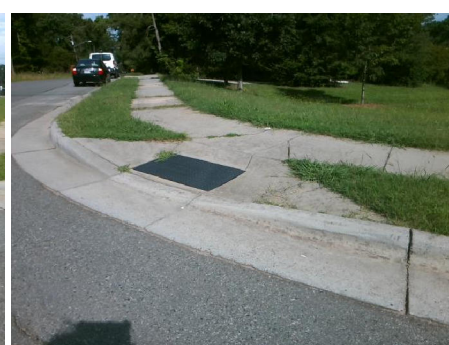
Not Found, R304.5.1, R304.2.2, R304.5.3

Compliance	Description	Data	Compliance	Description	Data
N/A	Ramp Length (in)	46.5	No	Ramp Slope (%)	9.0
No	Ramp Width (in)	29.0	No	Ramp XSlope (%)	4.1
N/A	Flare Type LT	N/A	N/A	Flare Type RT	N/A
N/A	Flare Slope LT (%)	N/A	N/A	Flare Slope RT (%)	N/A
N/A	Flare Traversable LT?	N/A	N/A	Flare Traversable RT?	N/A
N/A	Landing Length (in)	N/A	N/A	DWS Provided?	N/A
N/A	Landing Width (in)	N/A	N/A	DWS Contrast?	N/A
N/A	Landing Slope (%)	N/A	N/A	DWS Length (in)	N/A
N/A	Landing X Slope (%)	N/A	N/A	DWS Full Width?	N/A
N/A	Landing Curb? (Y/N)	N/A	N/A	DWS Offset (in)	N/A
N/A	Shared Landing?	N/A			
N/A	Gutter Ponding?	N/A	N/A	Gutter Slope (%)	N/A
N/A	Gutter Lip Ht (in)	N/A	N/A	Gutter X Slope (%)	N/A
N/A	Painted X Walk1?	No	N/A	Painted X Walk2?	N/A
	X Walk 1 Direction	To S		X Walk 2 Direction	N/A
N/A	X Walk 1 Width (in)	N/A	N/A	X Walk 2 Width (in)	N/A
	X Walk 1 Slope (%)	0.5		X Walk 2 Slope (%)	N/A
	X Walk 1 X Slope (%)	3.7		X Walk 2 X Slope (%)	N/A

N/A	Ramp inside XWalk1?	N/A	N/A	Ramp inside XWalk2?	N/A
	Road Slope (%)	N/A	N/A	Clear Space?	N/A
	Road X Slope (%)	N/A	N/A	Clear Space to XWalk (in)	N/A
N/A	Any Obstructions?	N/A	N/A	Storm Grate/Utility Hazard?	N/A
	Obstruction Type			Storm Grate/Utility Type	
		N/A			N/A
			Yes	Surface Condition? (G/P)	Good

Remove & Replace Entire Ramp.
